RCI Western Canada Chapter 2012 Winter Seminar

Single-ply Membrane Sloped Roof Retrofit

Presentation by
Guillaume Vadeboncoeur, P.Eng, LEED AP

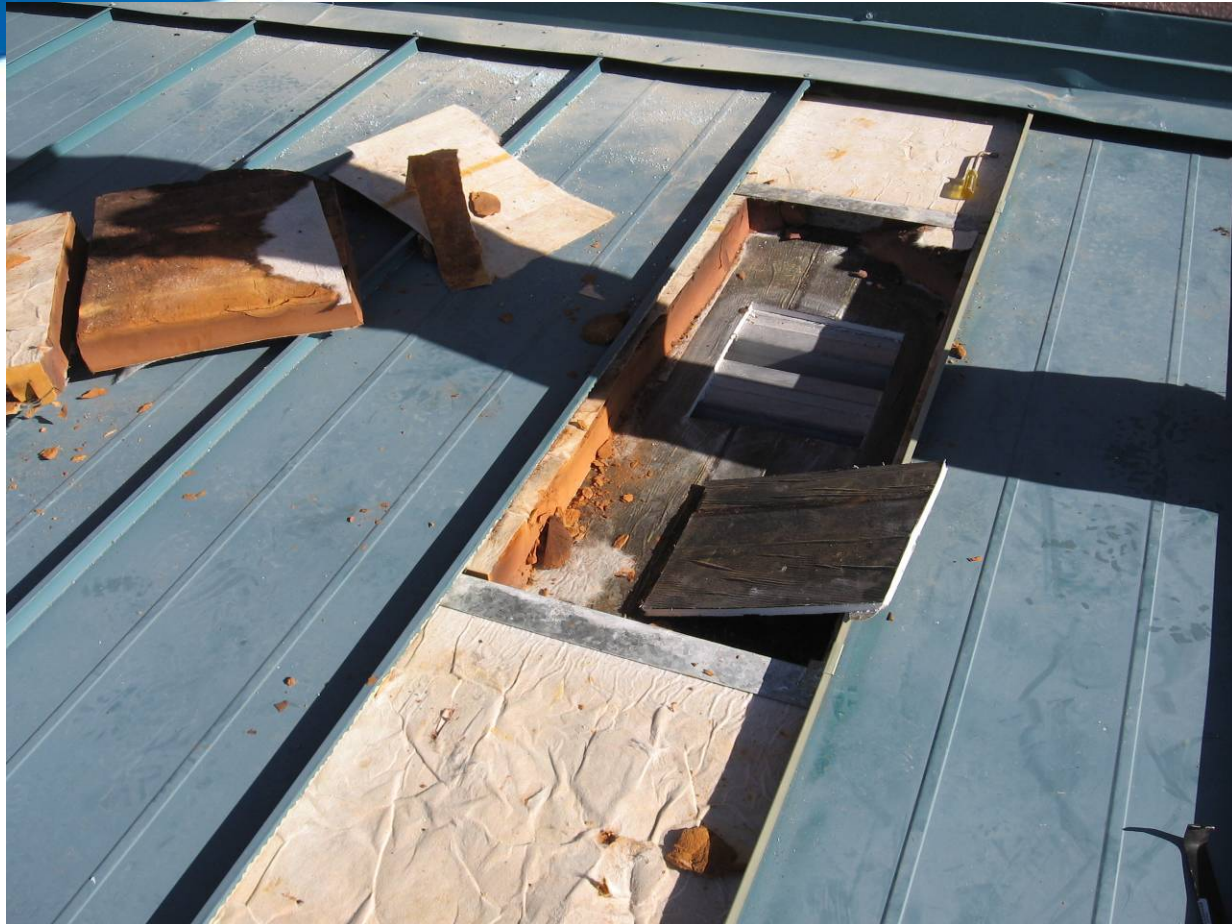
Water appeared to penetrate past the metal panels at the following locations:

- Roof crickets
- Skylight details,
- Eave (ice damming)
- Through the standing seams at the eave.

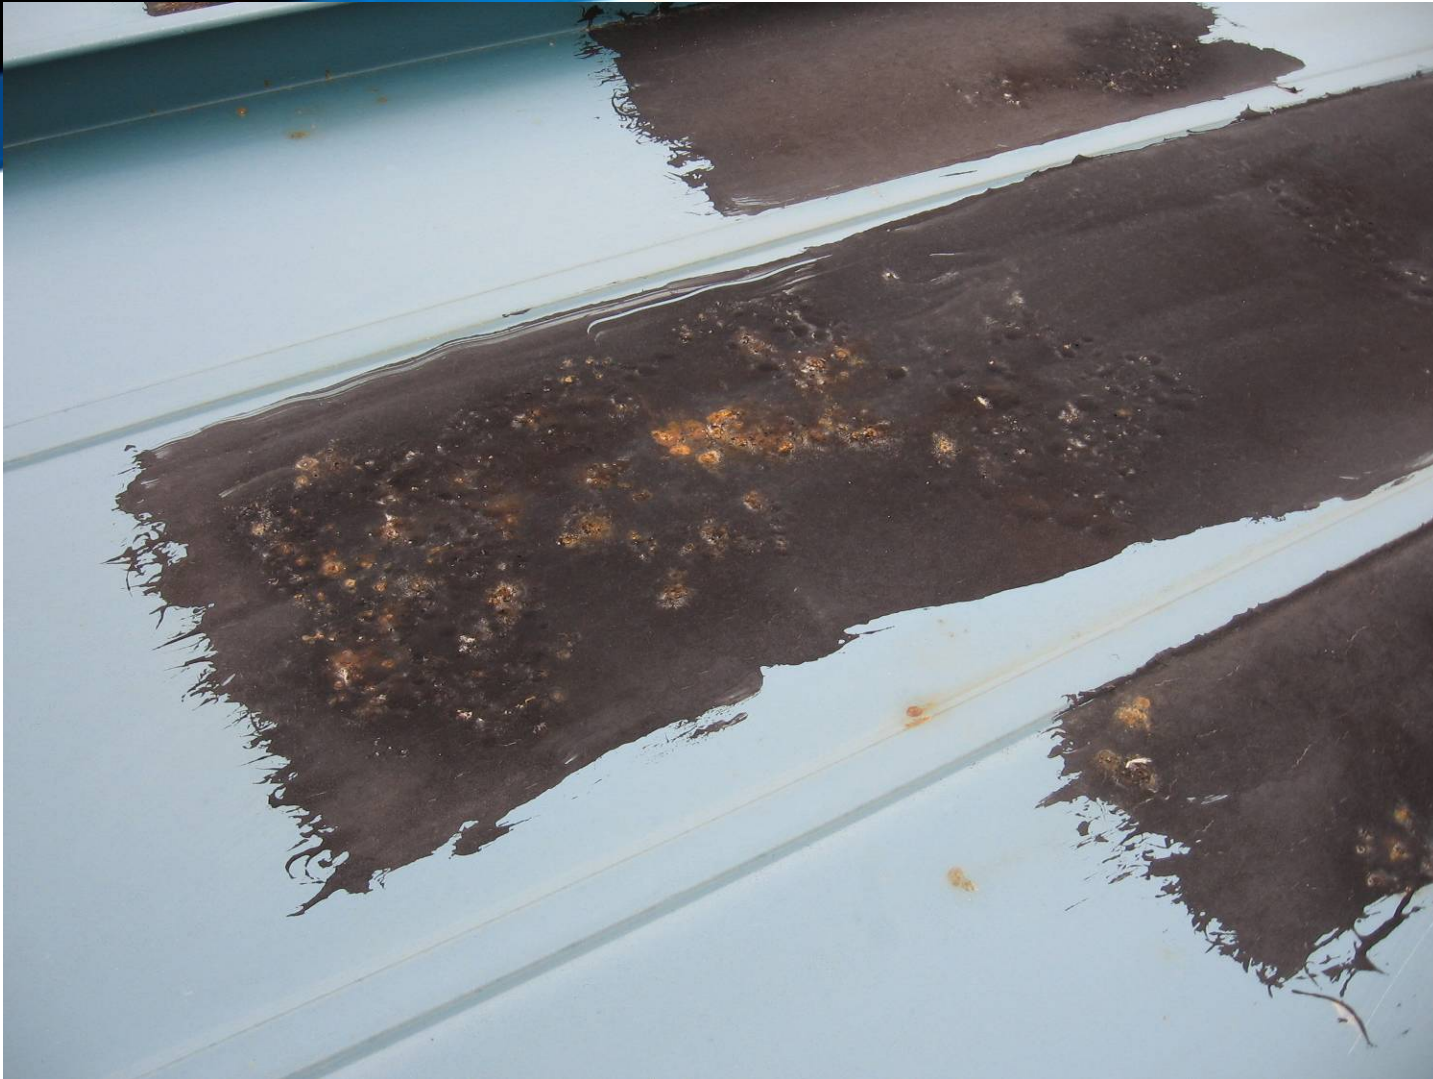
- The metal panels were corroded at several locations. Temporary repairs were performed throughout the years as the top surface of the panels was corroding at some locations.

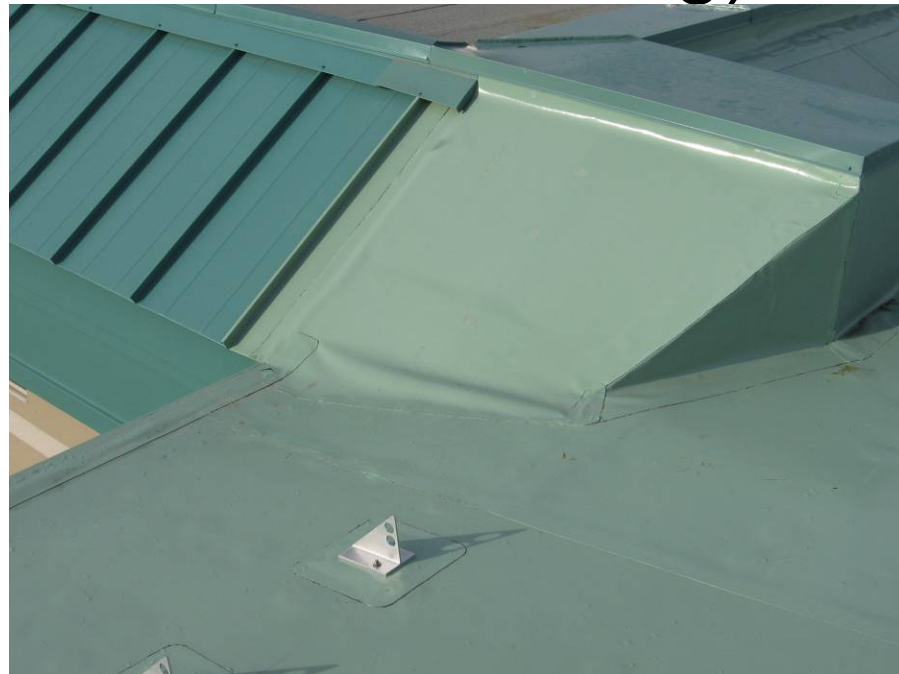
- Tricky details between existing sloped roof and new roof. (PVC coated flashing)

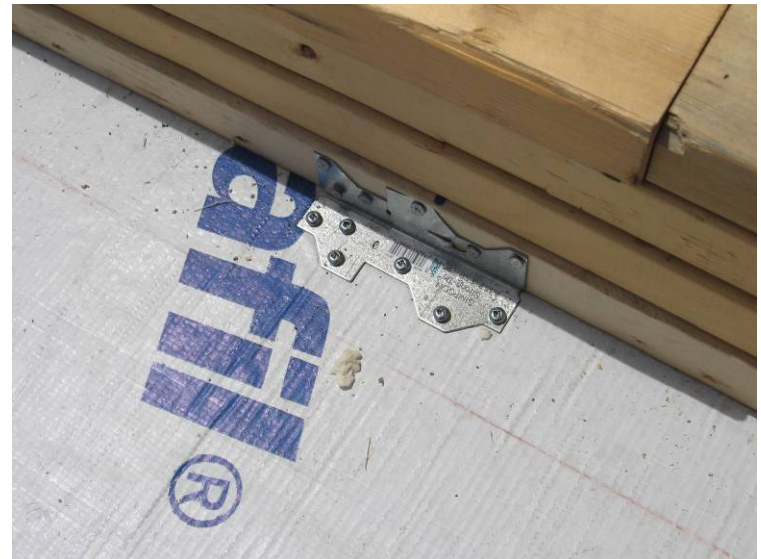
- Snow Guards. Our structural engineer did some pretty robust details...
- Stacked 2 x 10 plates...
