ROOF DECK CONSIDERATIONS AND CASE STUDIES

Vancouver, May, 11, 2018

Jerry Abendroth, RCC, RWC, REWC, RBEC, RRO, CDT

Roof Deck Discussion
Related Case Studies

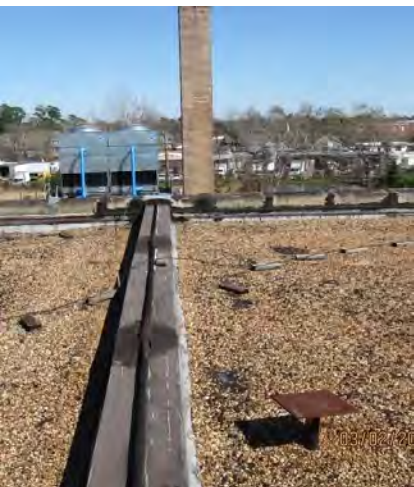
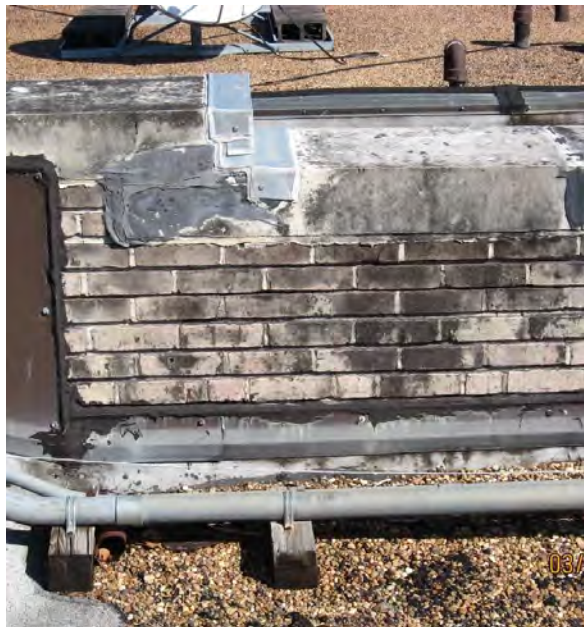
- ▶ Deteriorated brick parapet walls
- ▶ Open expansion joints
- ▶ Deteriorated roof top equipment that had to be replaced

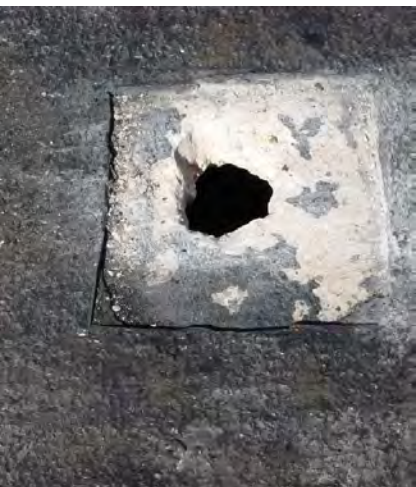
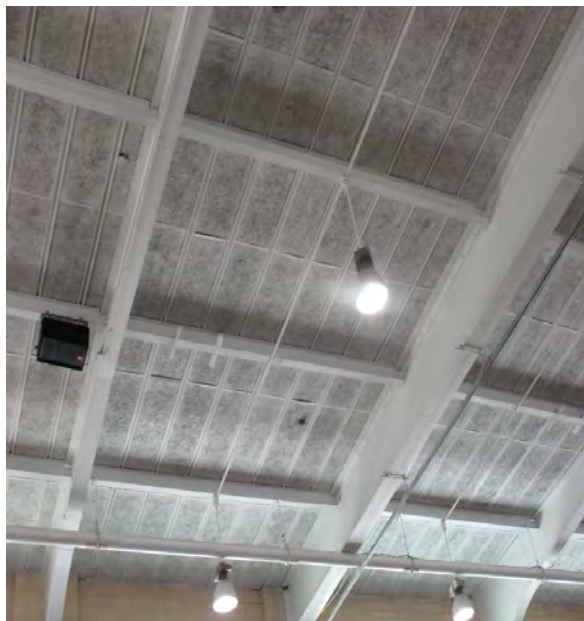
- ▶ Poured-in-place lightweight concrete deck
- ▶ Gypsum plank deck
- ▶ Tectum plank deck

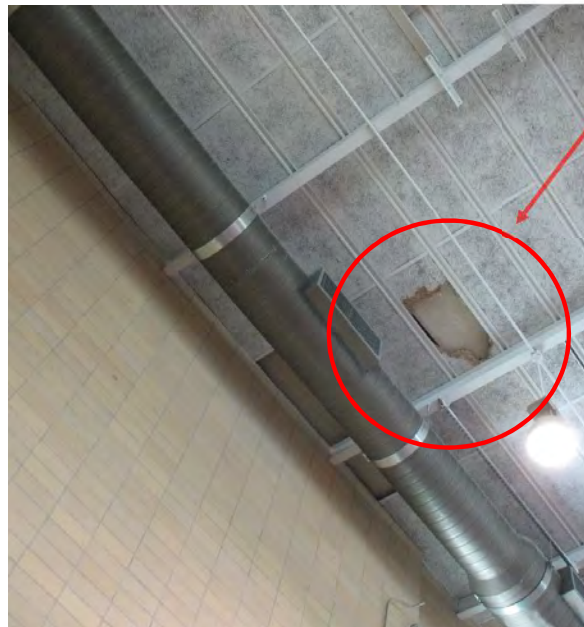
- ▶ On the first several decks, the workers were protected properly.
- ▶ On the gymnasium roof deck, a “soft area” was discovered, marked, and covered with plywood.
- ▶ The plywood was moved during demolition and the area was exposed.
- ▶ One of the workers fell through the “soft area” and was badly injured.

- ▶ Safety is always the responsibility of the General Contractor and subcontractors. Safety can and must be included in the project documents, however, specific issues should not be addressed by the Architect/Engineer/Consultant.
- ▶ Just as the school had to decide whether to demolish the school and rebuild, or to renovate, the Architect/Engineer/Consultant team had to make that same decision for deteriorated roof decks.
- ▶ All of the roof decks should have been completely removed and replaced.

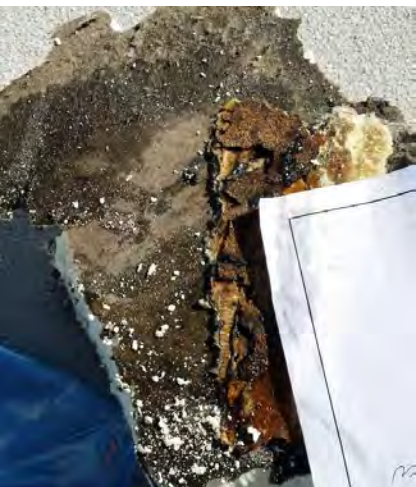
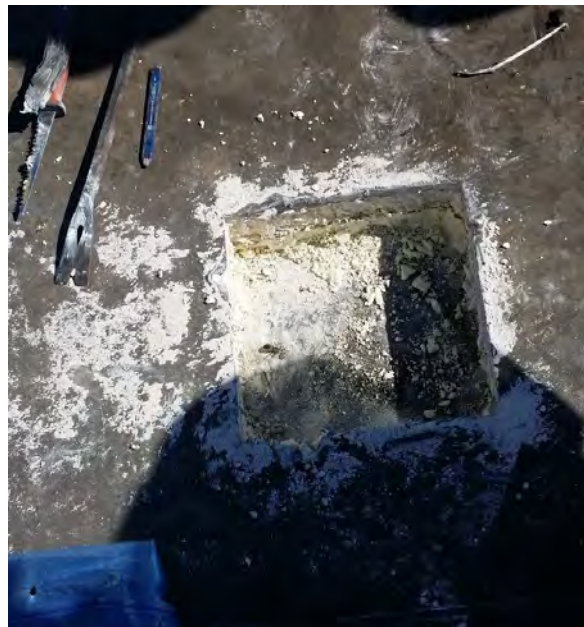
- Test cuts revealed condensation between the concrete roof deck and the first layer of insulation.

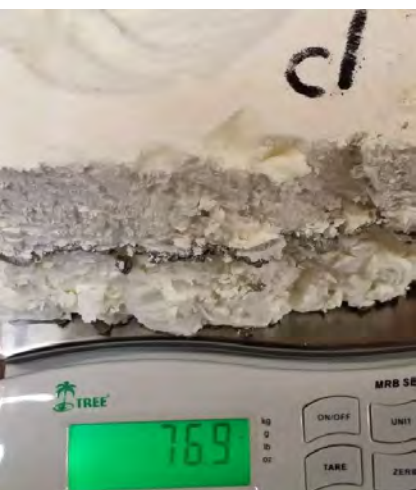
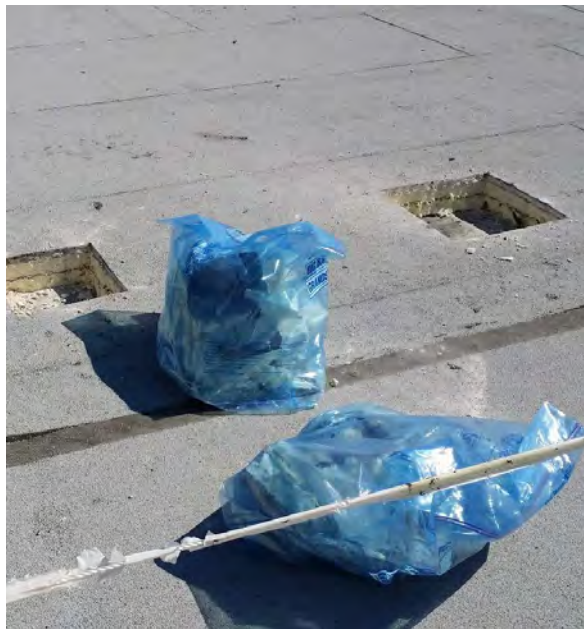
- Gravimetric testing was employed to evaluate before and after moisture content by weight

- ▶ BES reiterates its recommendation to install in the roof membrane metal one-way roof vents at intervals of one roof vent per 500 square feet to assist in the removal of water vapor from the roof system. In addition to roof vents, BES recommends that additional test cuts are conducted in the late winter as the WUFI models predict that at this time, the potential for condensation at the concrete deck surface will be the least and the water that is potentially from condensation in the roofing assembly will have had the more time to be removed from the system via vapor drive and the relative humidity of the concrete (adsorbed water content) will be at the lowest level of the yearly cycle.

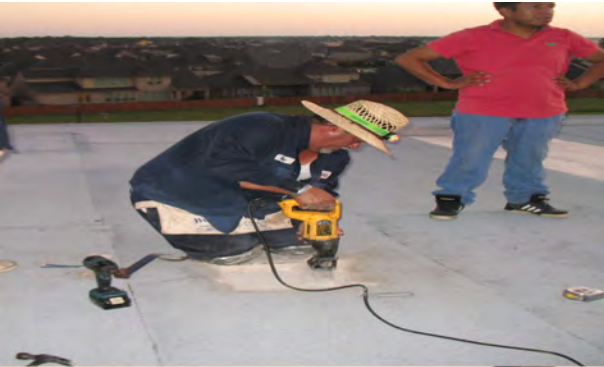
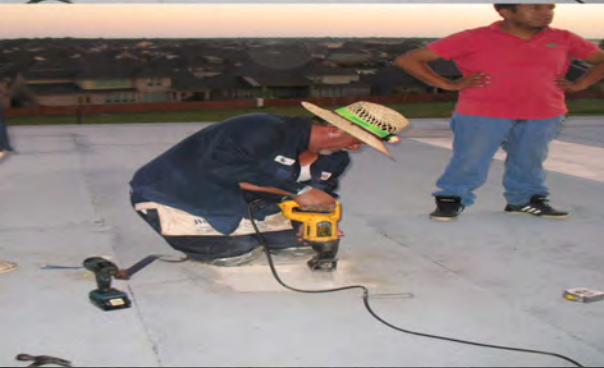
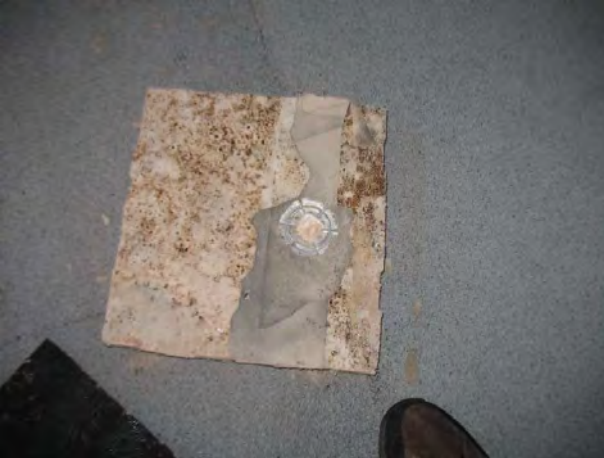
- ▶ Test cuts indicated discoloration of the lightweight insulating concrete.
- ▶ Fasteners for the modified bitumen roof system were placed properly and did not show advanced signs of dislodging or rusting.

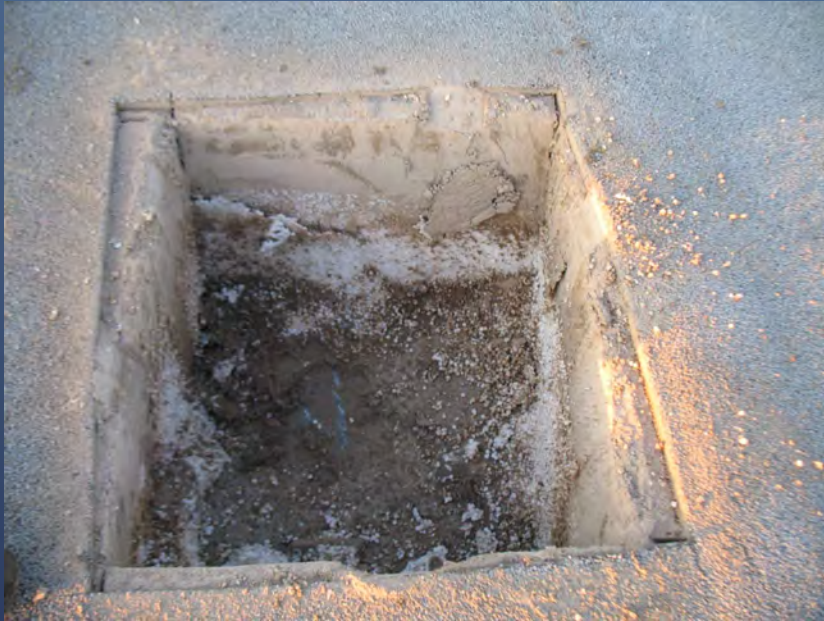
- Moisture accumulation was evident at the interface of the deck and the insulating concrete.

- ▶ A consultant had recommended adding one-way roof vents during the previous year.
- ▶ The following year, in June, July and August, the leaking reoccurred.
- ▶ Interviews were conducted with maintenance personnel and it was discovered that the air conditioning in the gymnasium was turned completely off after school let out in the spring.
- ▶ The humidity in the room rose to as high as 70% on some days.
- ▶ The roof system had not been designed for the constant additional humidity.
