MULTI-FAMILY APARTMENT CONSTRUCTION AND RELATED CASE STUDY

Vancouver, May, 11, 2018

Jerry Abendroth, RRC, RWC, REWC, RBEC, RRO, CDT

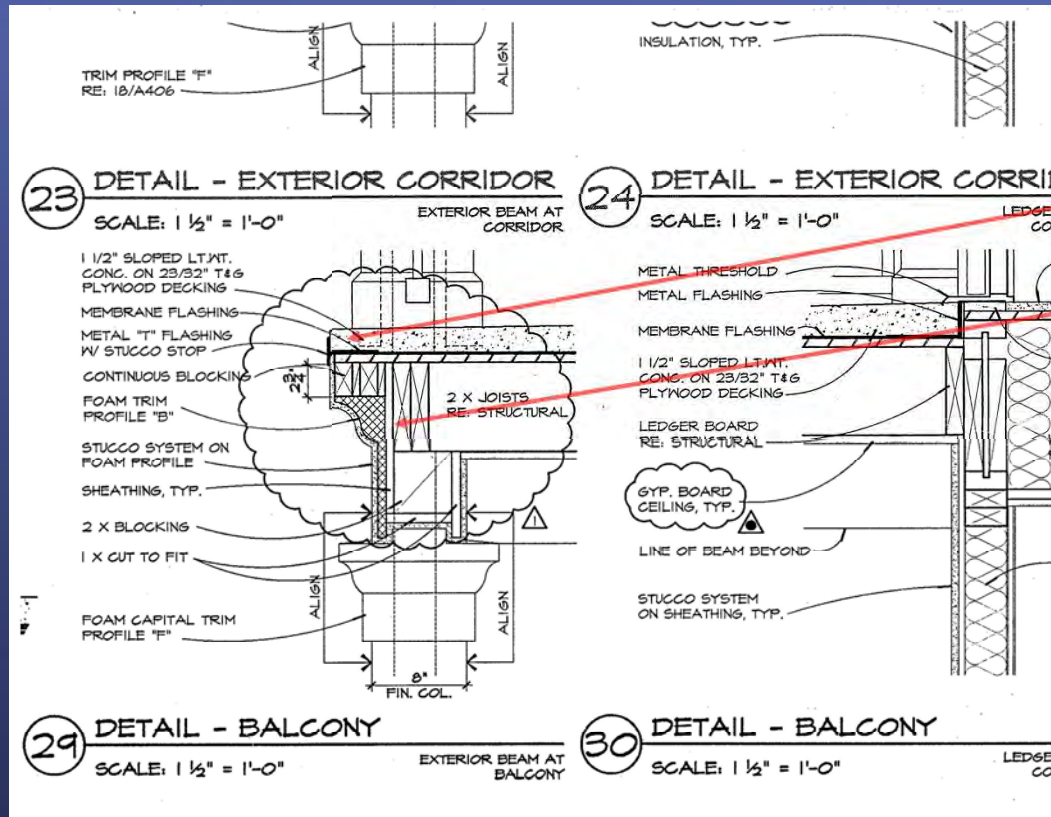
T-bar illustrated "tight" to fascia

Waterproofing layer not illustrated behind fascia

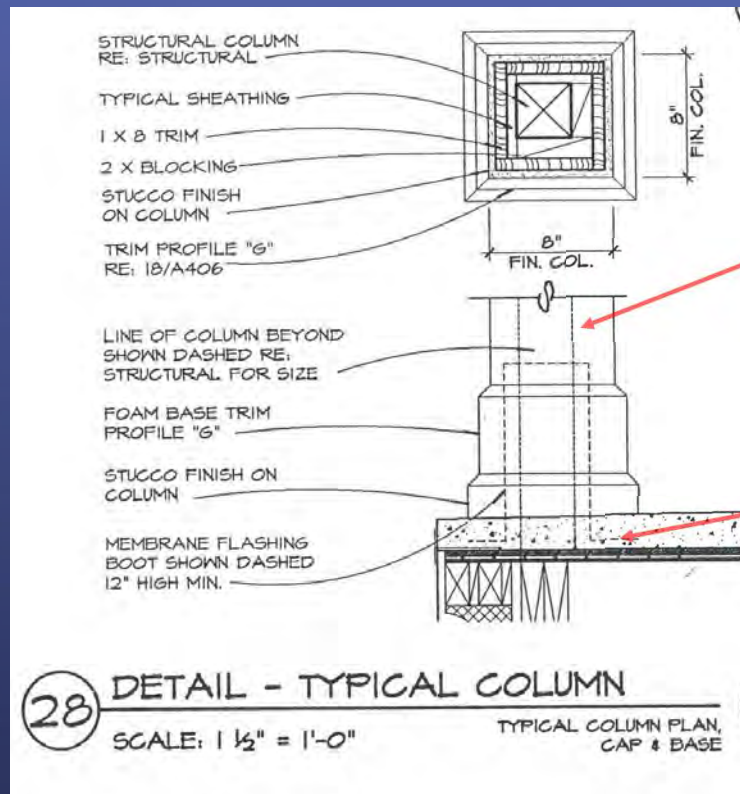
No waterproofing layer illustrated at column

Tie-in of waterproofing layer not shown on documents

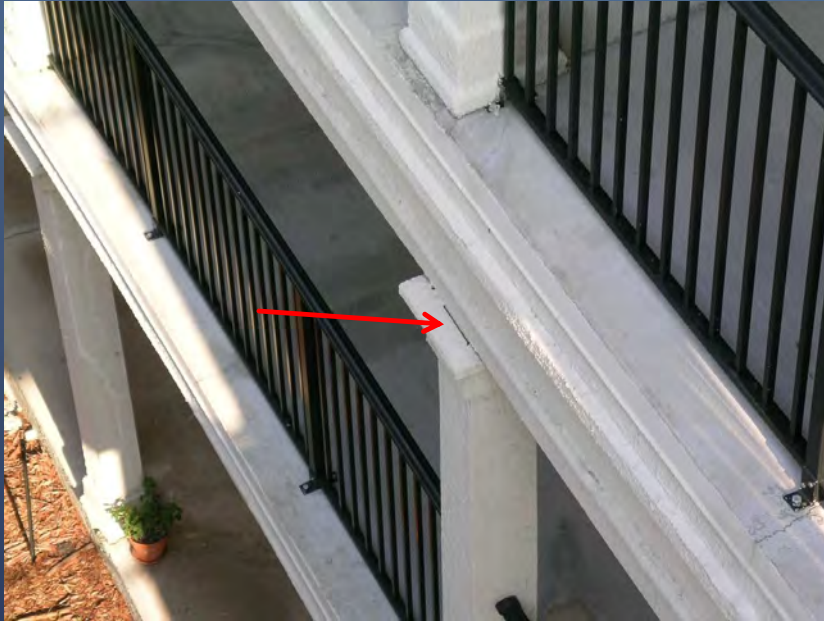
► Open column cap at walkway

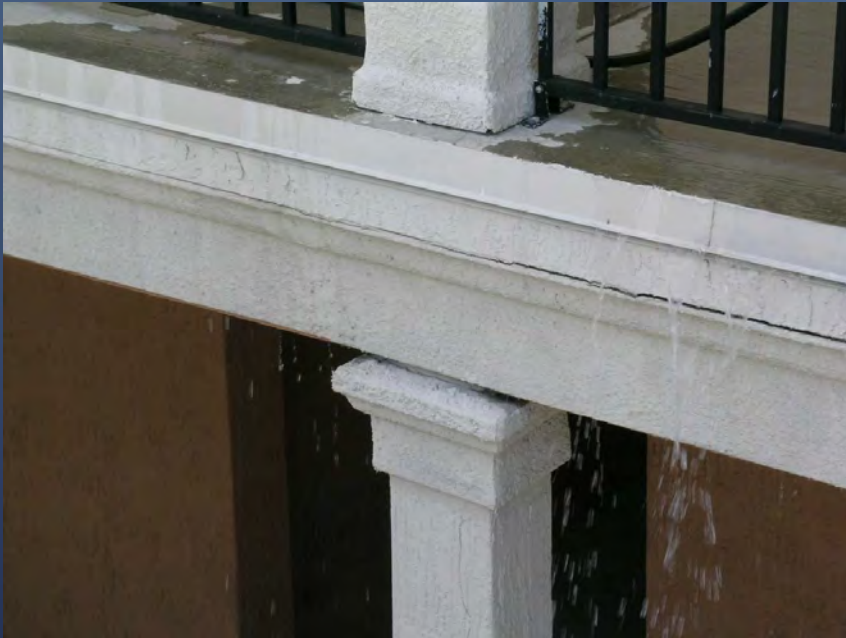
Water flowing off walkway onto
column cap

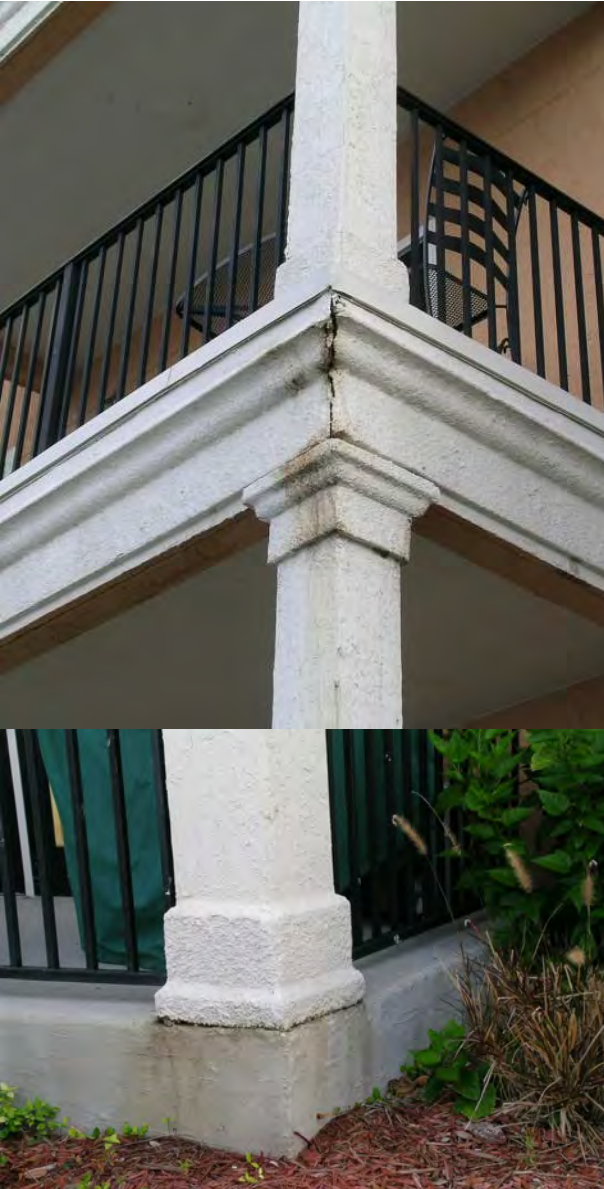
► Water infiltrating through the columns

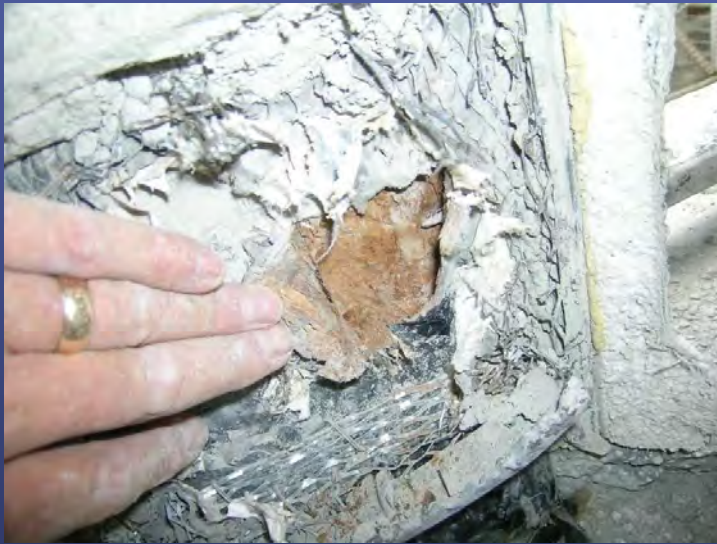
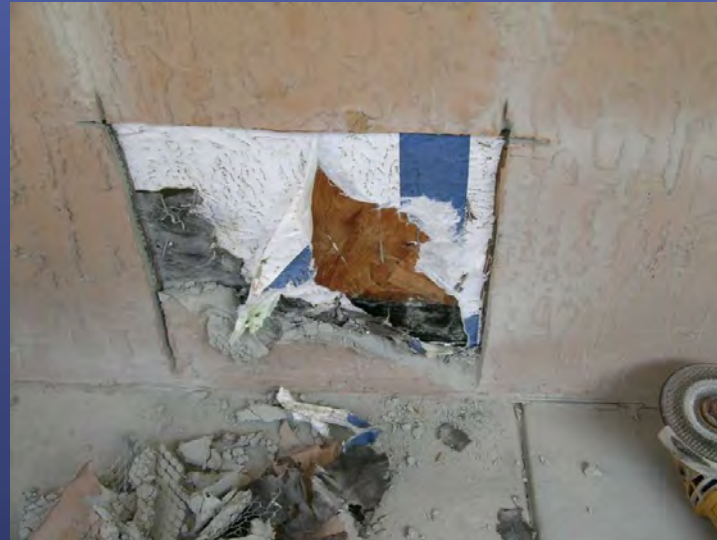
Lack of integration at base flashing

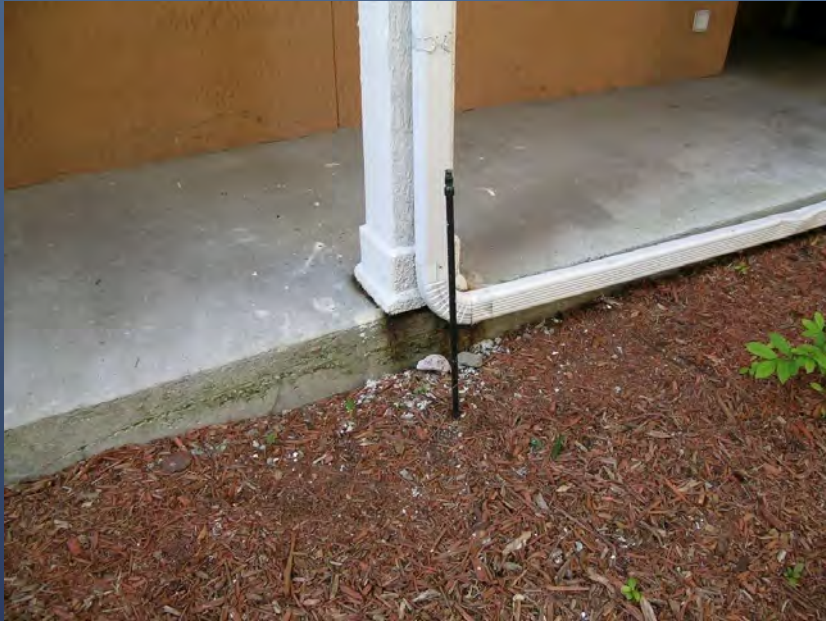
- Water stains (rot) below column

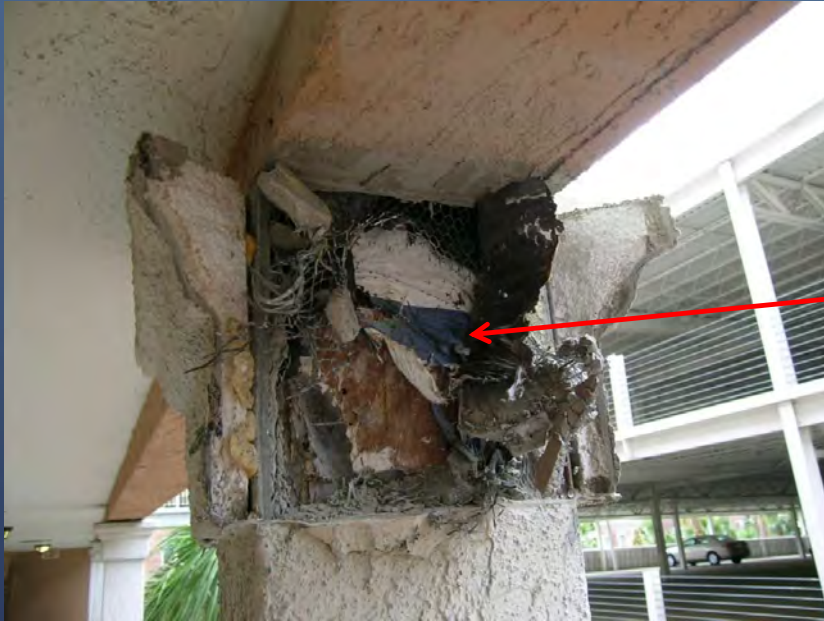
- Destructive opening at the column cap in 2005 indicating partial installation of the Tyvek membrane and the paper back lath. Moisture from the top of the column cap drained behind this system

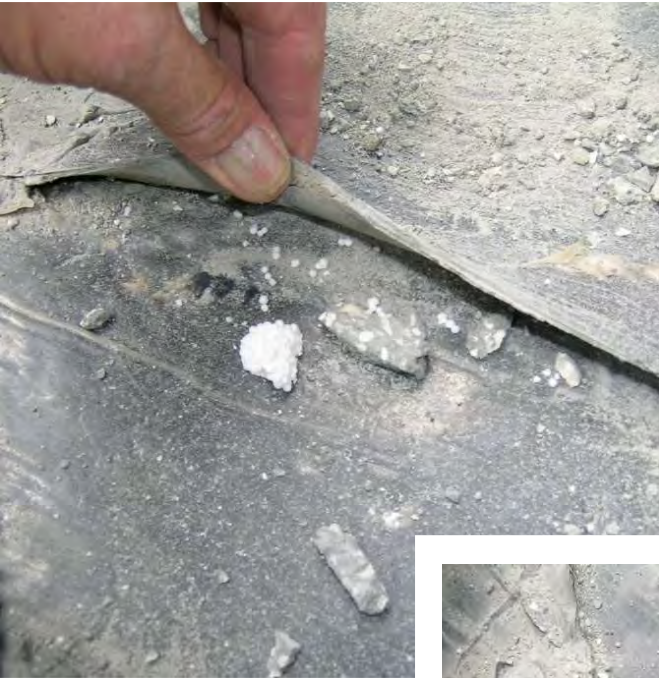
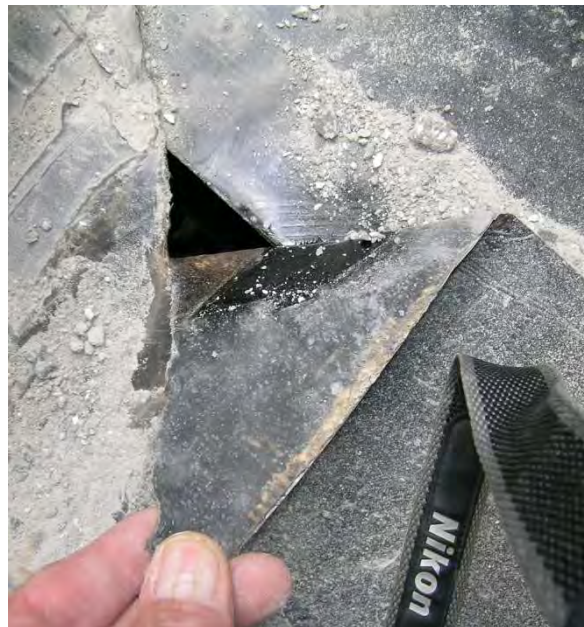
- Waterproofing not adhered at critical junctures

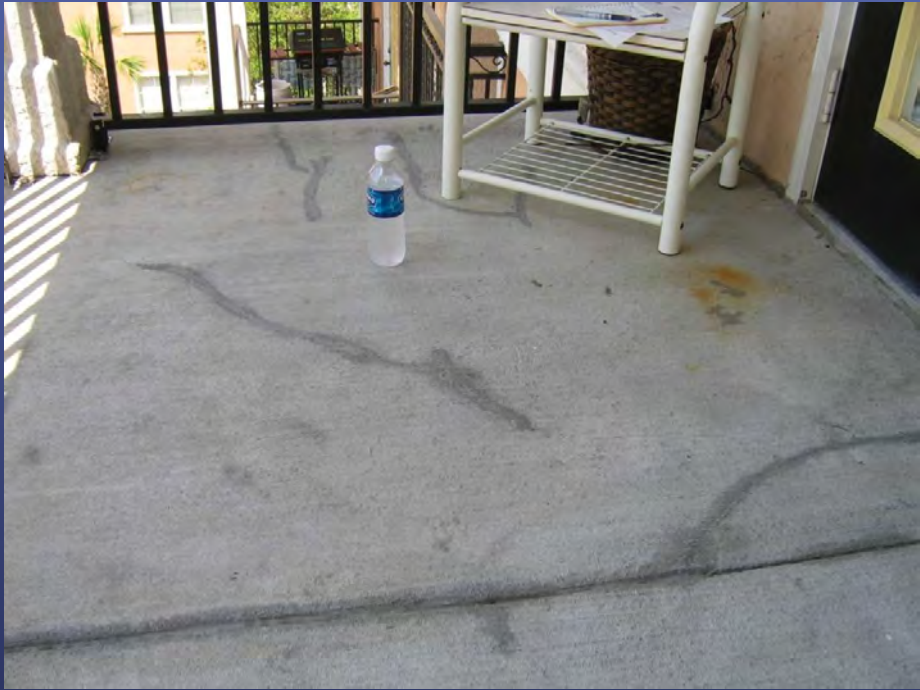
Red - Severe damage requiring immediate repair and remediation
-

Example of a red balcony

1. Remove and replace all concrete topping and waterproofing membrane.
2. Repair wood framing and sheathing to extent required by damage observed.
3. Install new waterproofing membrane, protection course and drainage mat.
4. Install new concrete topping sloped to drain.

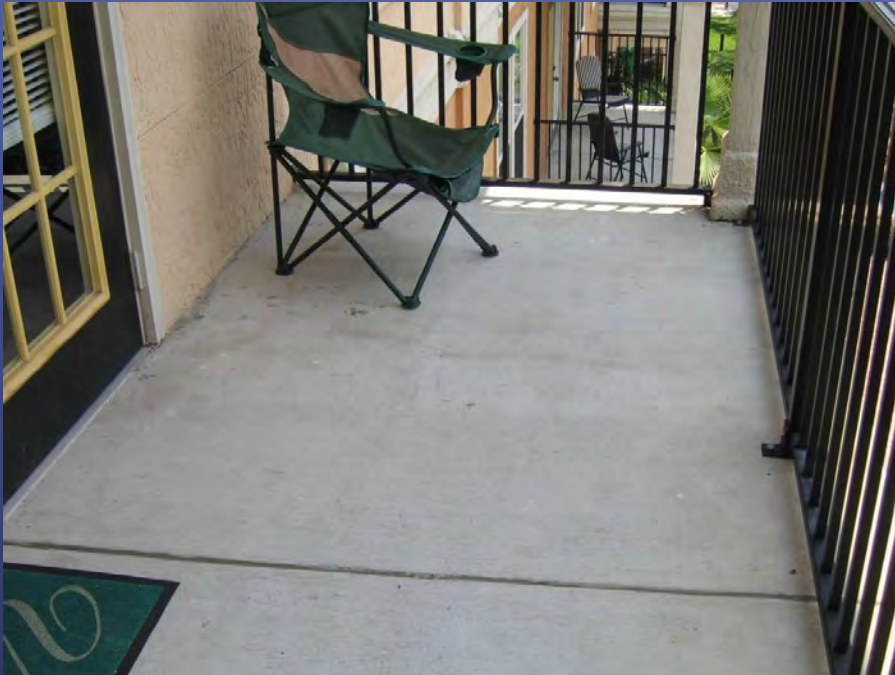
Yellow - Moderate distress and evidence of water infiltration
-

Example of a yellow balcony

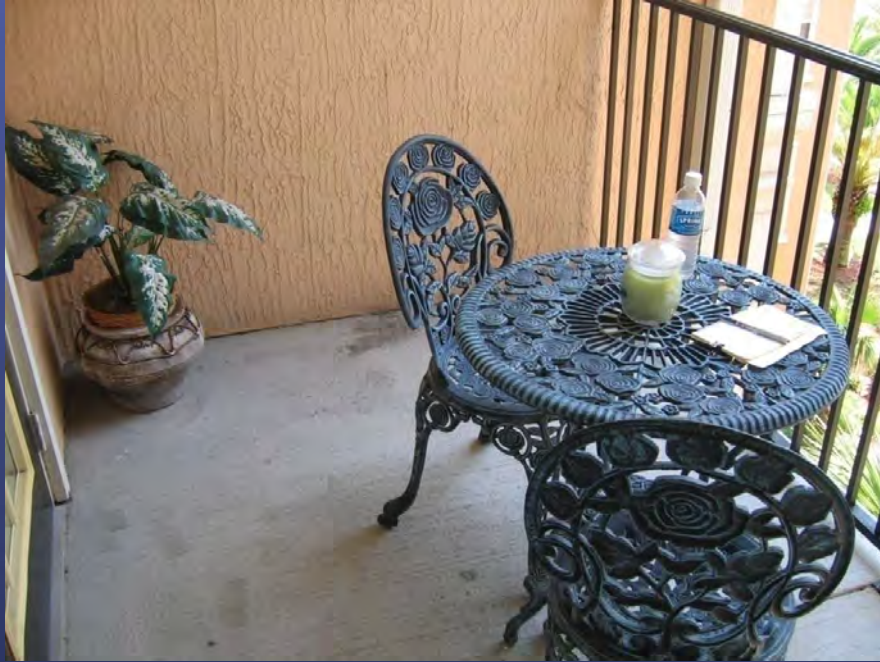
Green - Surface cracking only with little evidence of water infiltration

Example of a green balcony

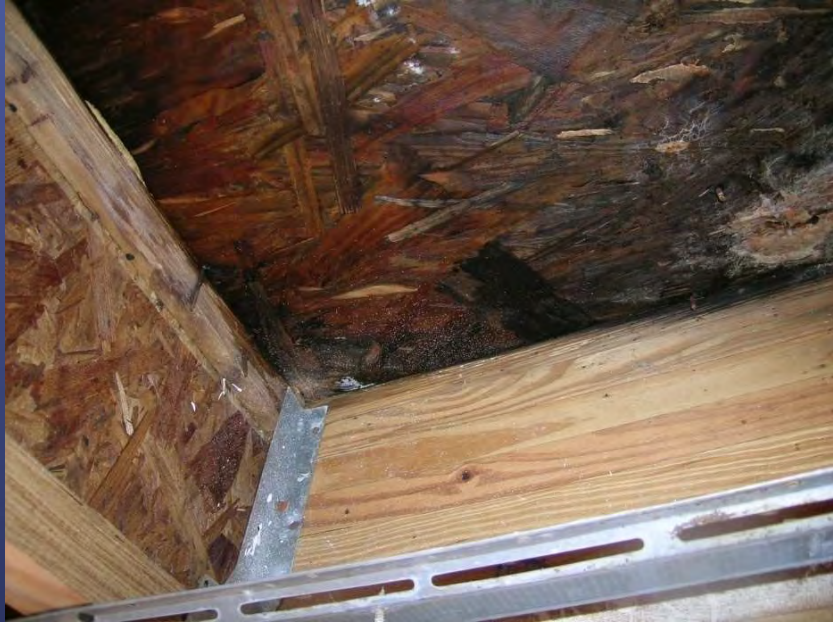
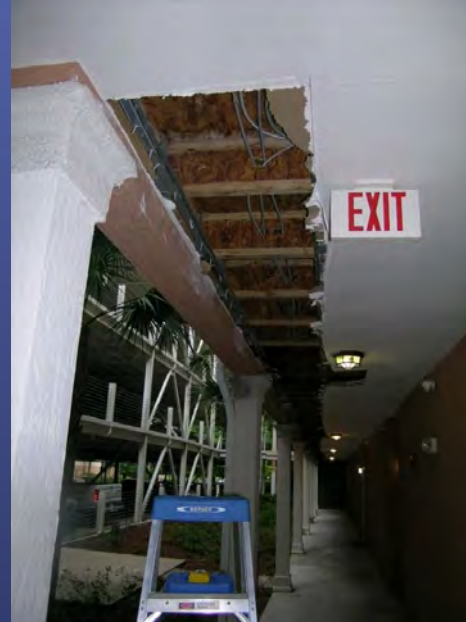
Example of damage at walkways

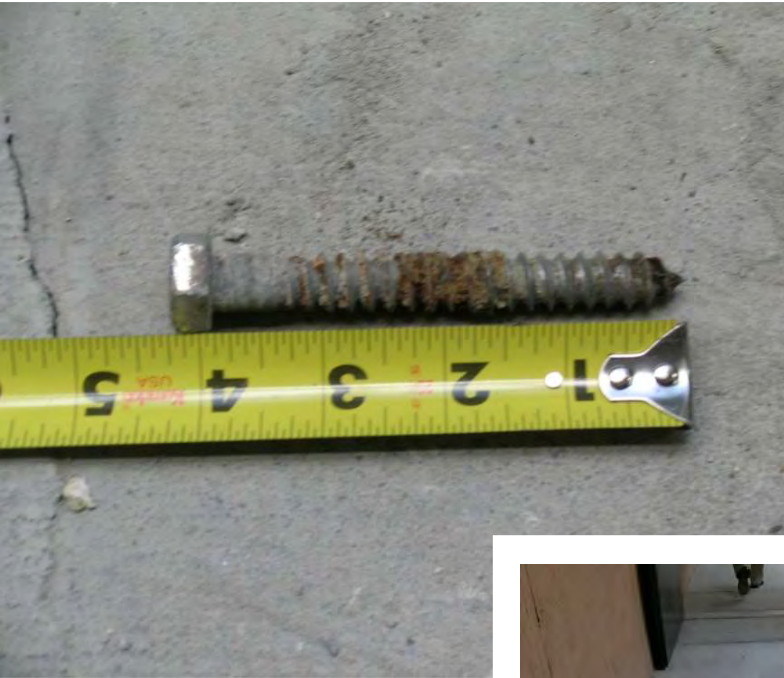
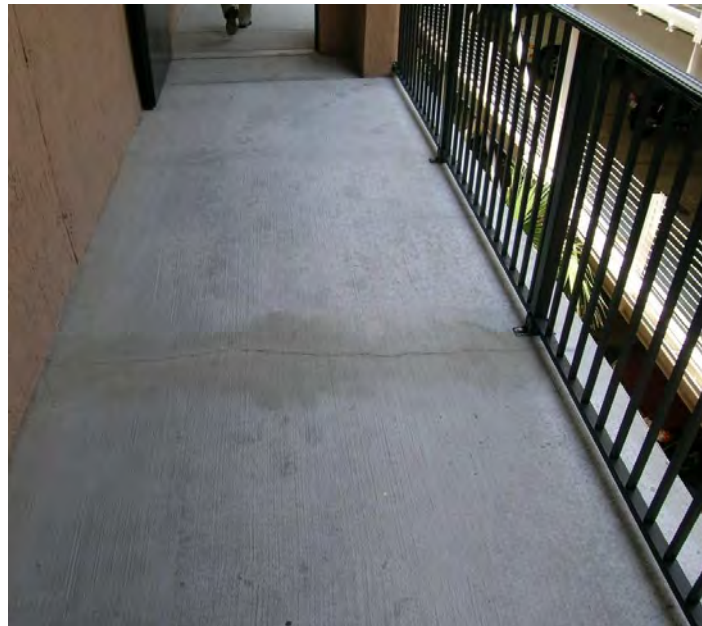
Penetration of
guardrail fasteners
through concrete
topping

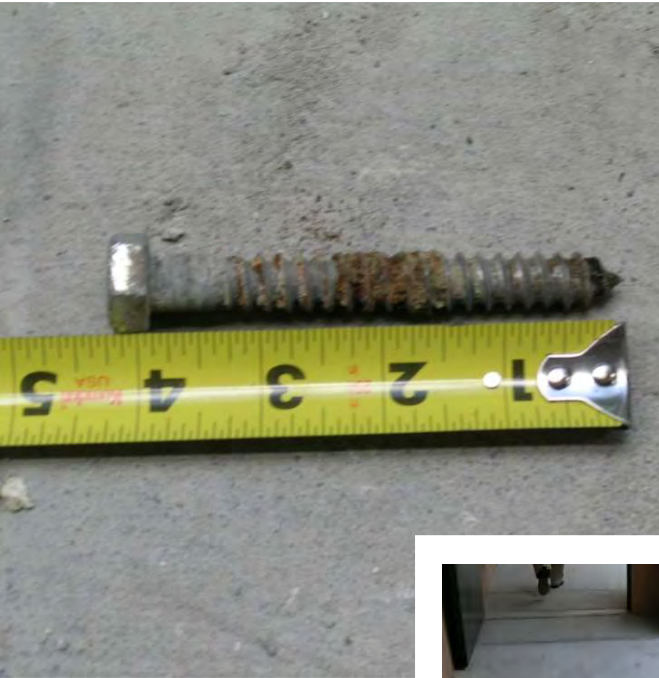
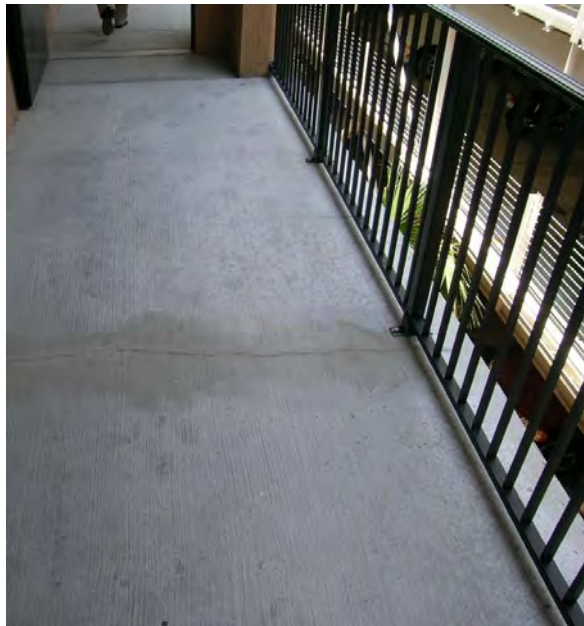
- ▶ Penetration of guardrail fasteners through concrete topping
- ▶ All penetrations indicated consistent leak patterns

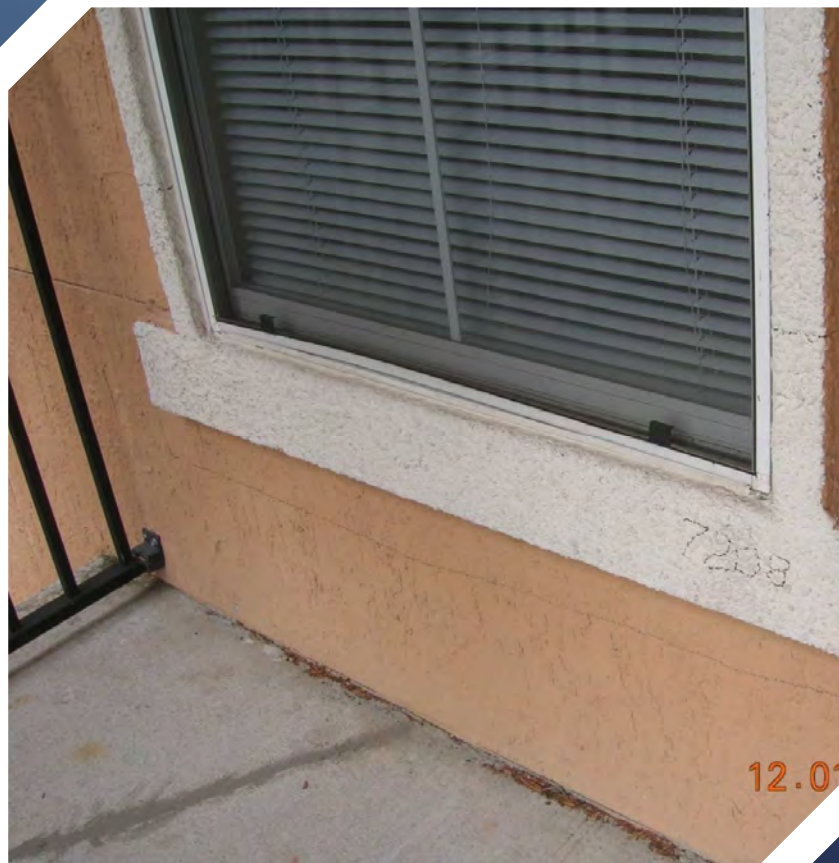
► Before stucco removal

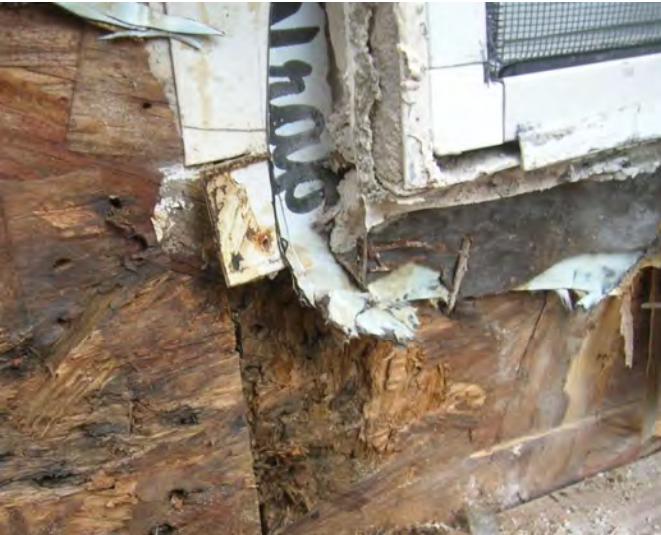
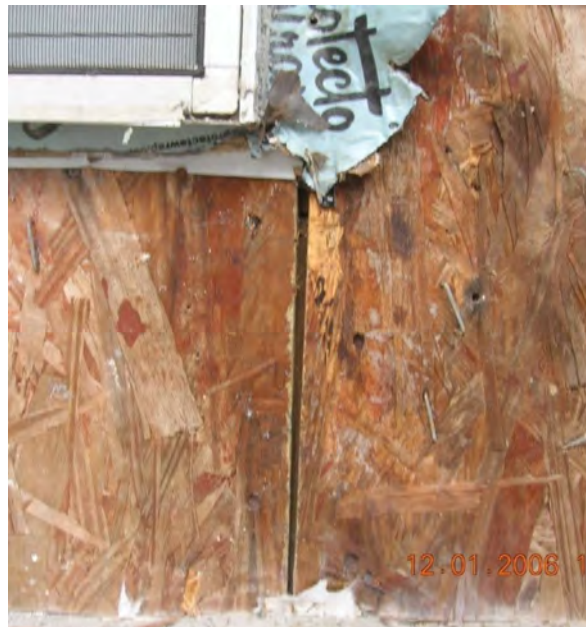
After stucco removal

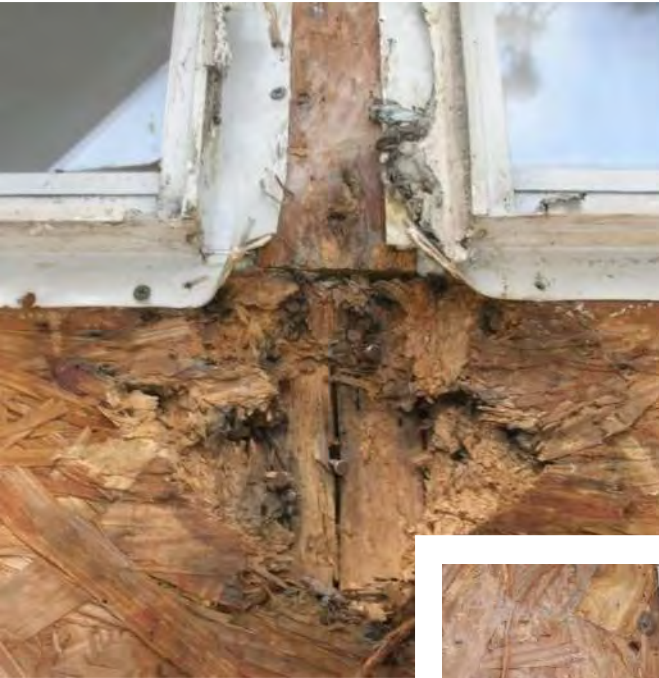
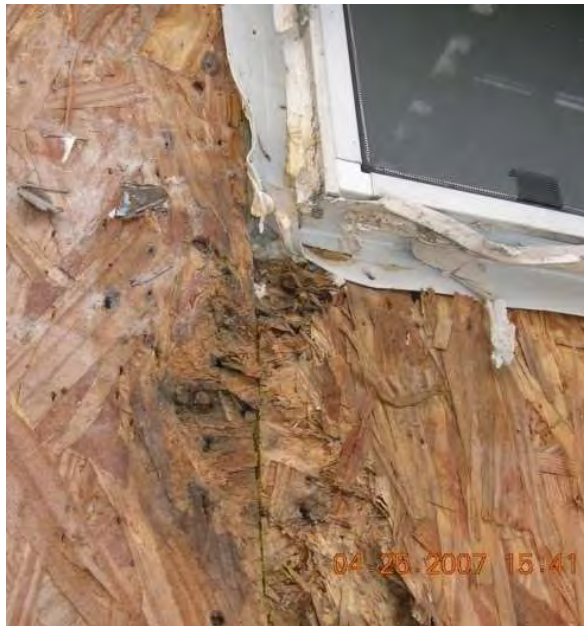
► Stucco removal at windows

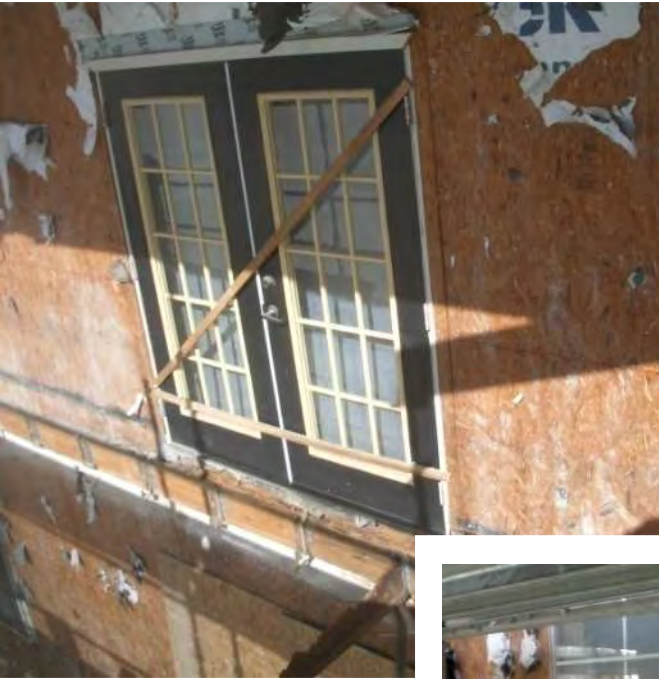
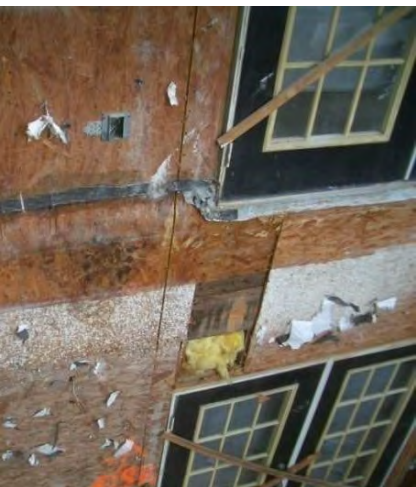
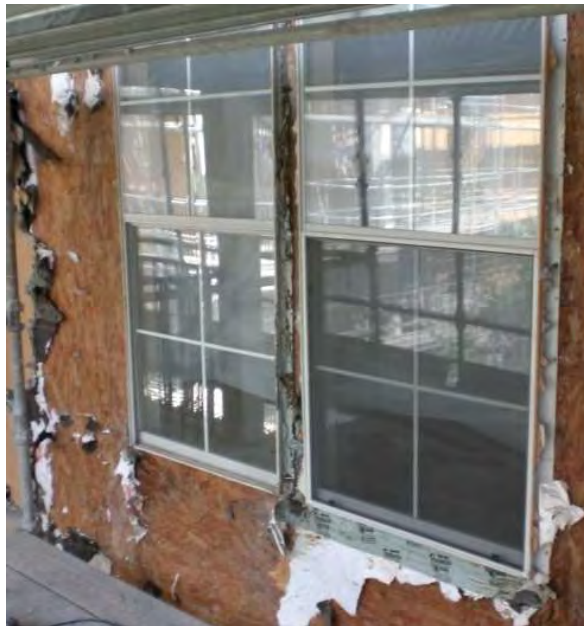
► Stucco removal

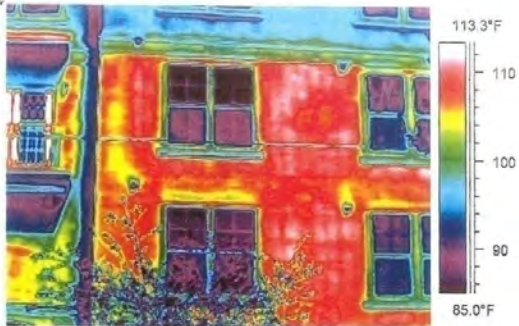
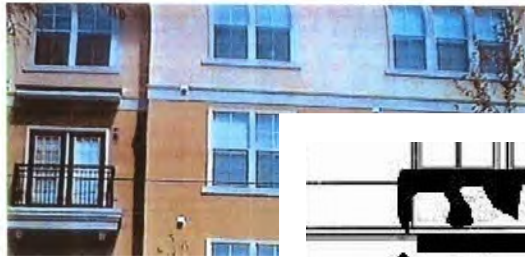
THERMAL VIEW OF SUSPECT AREA - BLDG. 5 - WEST ELEVATION

► Infrared scan

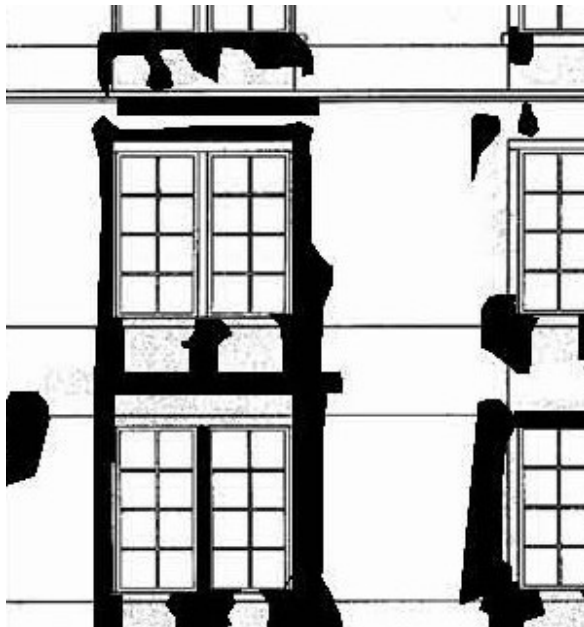
► Elevation with observation findings

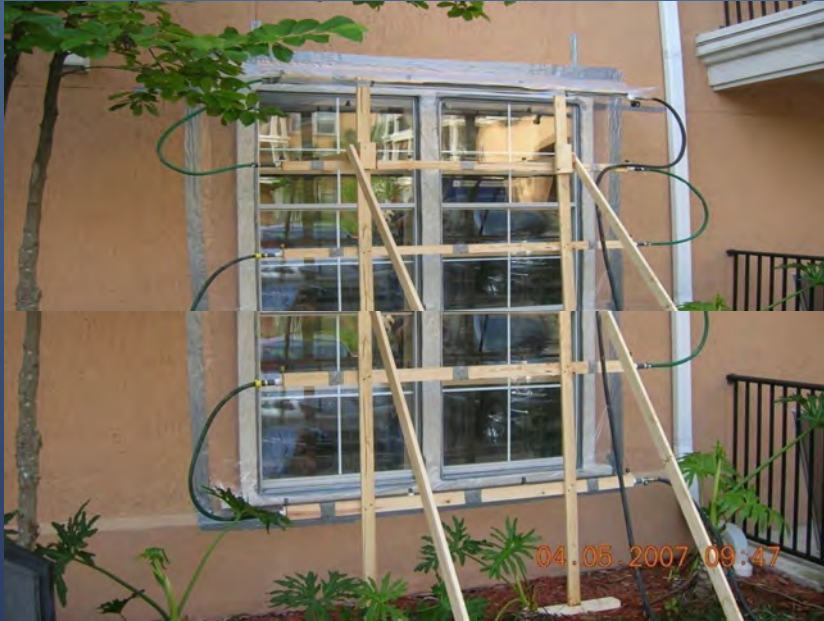
► Exterior spray rack

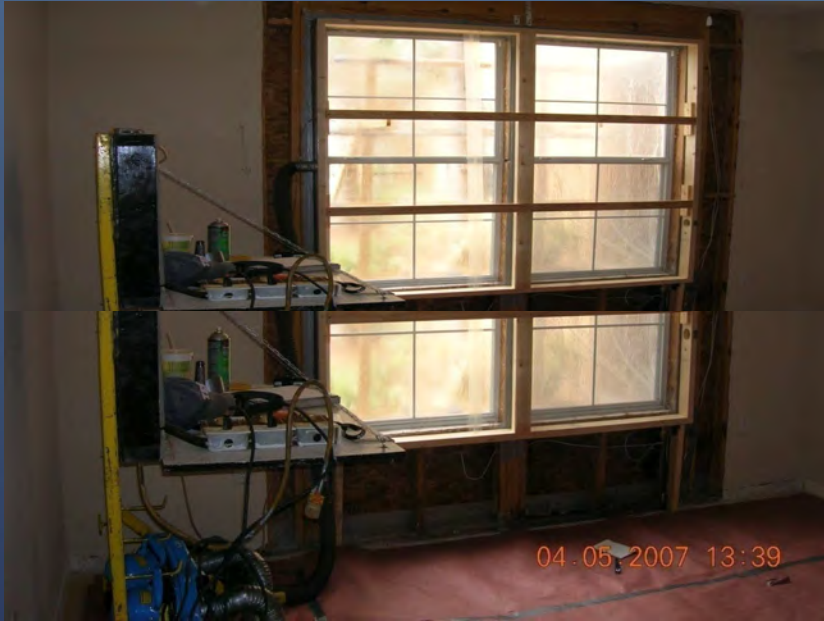
- Interior pressure chamber

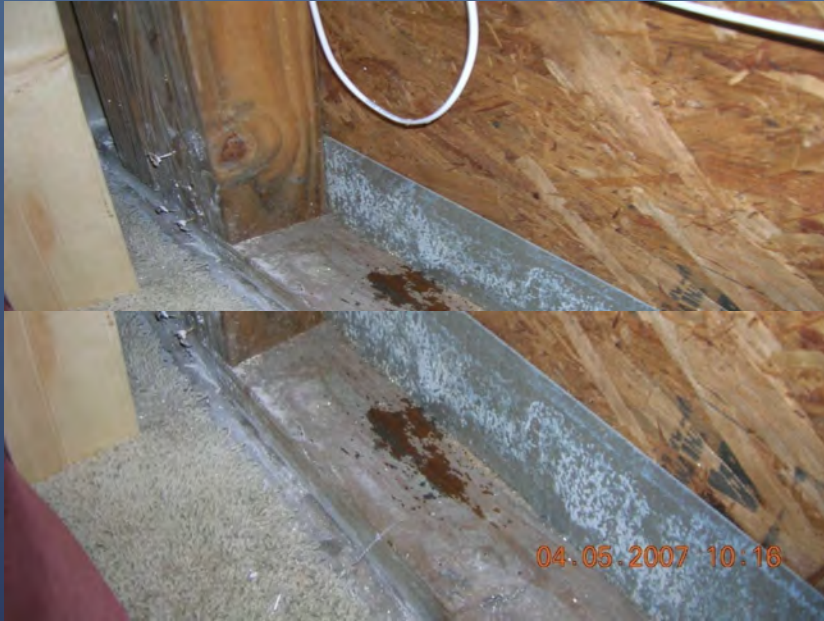
- Leak from alarm sensor

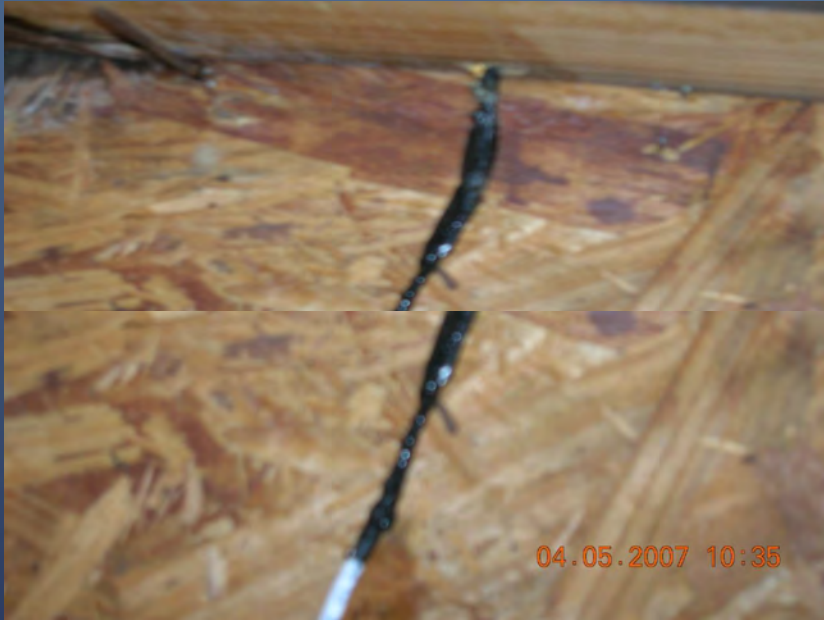
► Leak at unit alarm wire

- ▶ Replacement of limited number of windows after thorough investigation. Repair broken sills per the direction of the window manufacturer. Remove and replace all alarm connections.

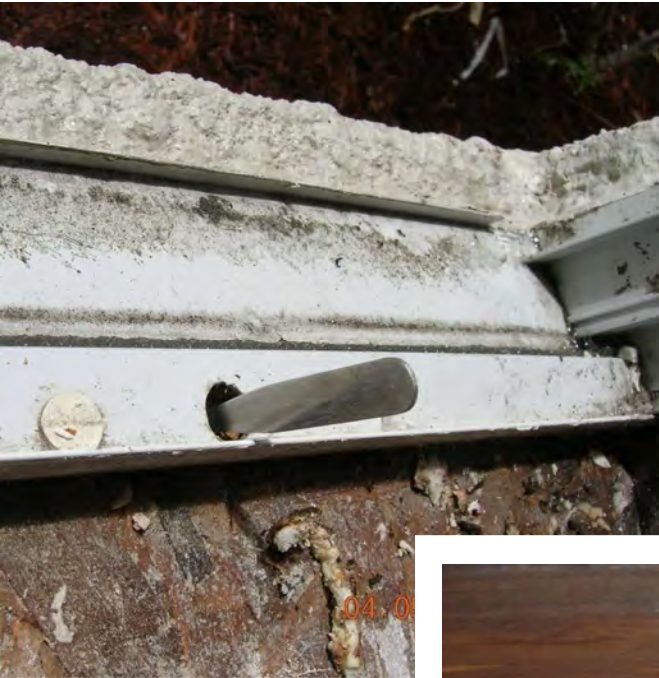
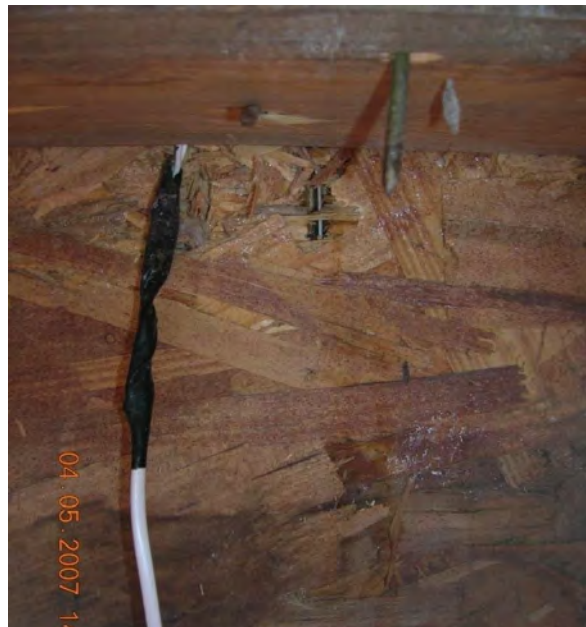
► Extra alarm hole

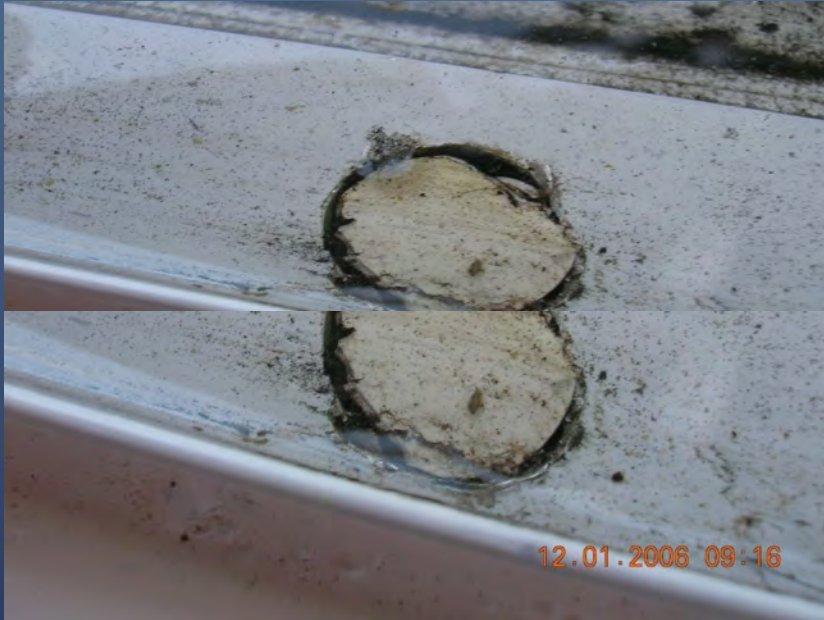
► Unsealed alarm hole
