RCIWCC TELEGRAM

SPRING 2018 Edition

Things That Happen Behind Your Back

By Ted Neef, RRO-BC Roof Inspections

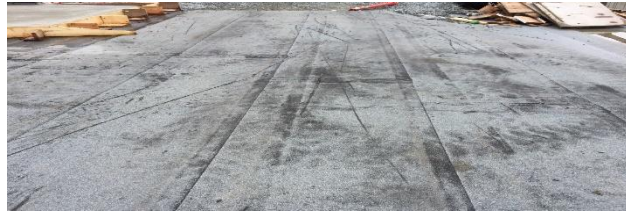
Driving Bobcats, boom lifts or other machinery over a completed SBS membrane installed to a concrete slab without installing protection will result in damage to the membrane. Using said Bobcat to push a pile of debris off the slab will result in deep gouges, rips and tears to the membrane. This type of damage is usually easy to spot. This type of damage must be corrected before being covered up.

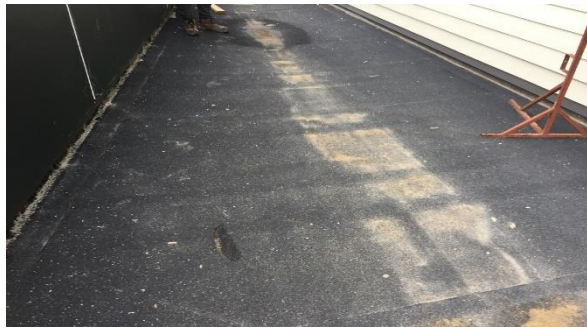
Damage to a completed membrane can also be caused from objects falling from above, or from concrete forms built over a completed waterproofing membrane. While this damage is large and clearly visible, other damage noted in this area was small and barely visible. (Upper Left)

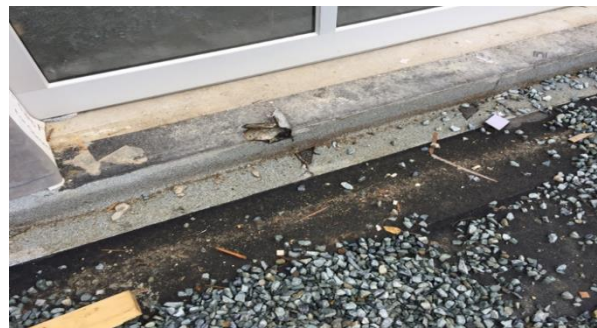
Another area that is frequently damaged are door thresholds. Many workers are likely to install doors over this damage. (Upper Right)

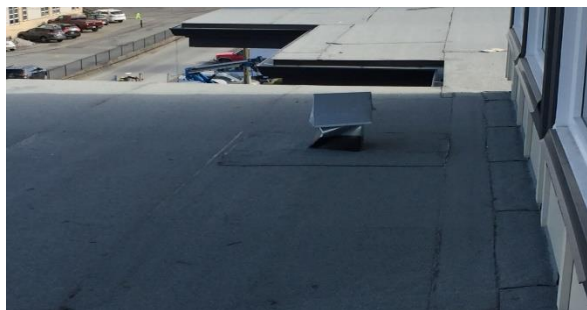
BUR vents are easily damaged by other trades. They can make good platforms to store items off the roof (when located a little closer together) or steps for reaching the next elevation. Sometimes though, they just plain get in the way. (Upper Left)

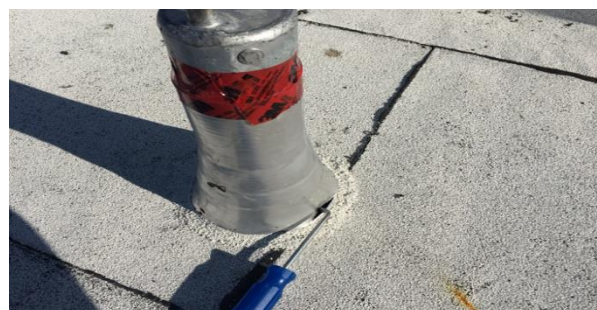
While most damage to vents or other roof protrusions is fairly obvious, closer inspection can reveal damage that is more difficult to see. In this case the damage was intentionally covered with granules in an attempt to hide the sin by the guilty individual. (Upper Right)

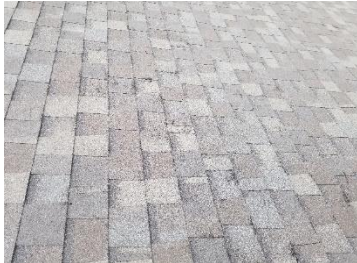
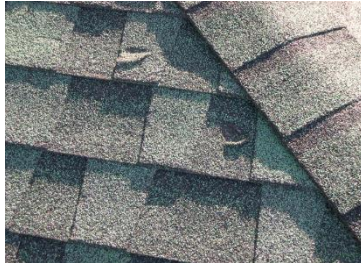
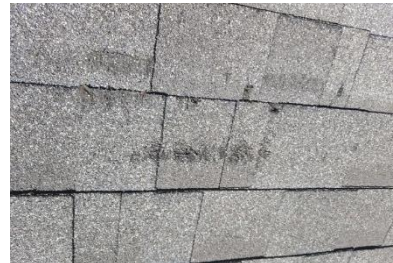
Scuff marks on asphalt shingles are quite common when the weather is warm. Some shingles are more resistant to scuffing than others. Most of the damage is a result of other trades working off of the lower roofs installing siding, windows, gutters or painting. Much of this damage occurs long after the roofing contractor has completed the work on that building.

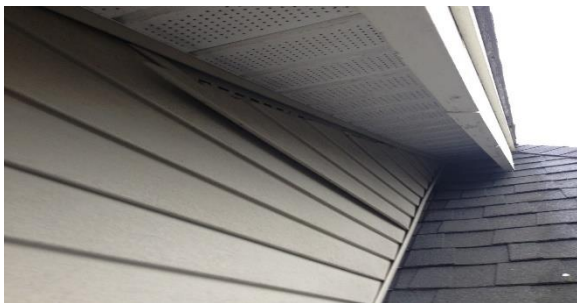
Siding that was removed during a re-roof needs to be checked to ensure that it was properly re-secured, particularly in hard to reach areas. This is also important on new construction as many times the contractor will cut corners here as it is difficult to secure the siding properly or difficult to access. (Upper Left)

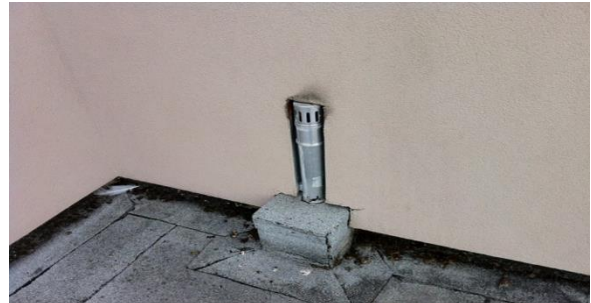
Issues with the placement of mechanical equipment or penetrations needs to be addressed before the roofing starts to avoid problems, such as this plumbing vent partially buried in the wall. (Upper Right)
