**RCI Western Canada Chapter  
Fall Waterproofing Seminar  
October 27, 2011**

# **“Integral Waterproofing”**

Case-study of a large high-rise project in False Creek in Vancouver, BC.

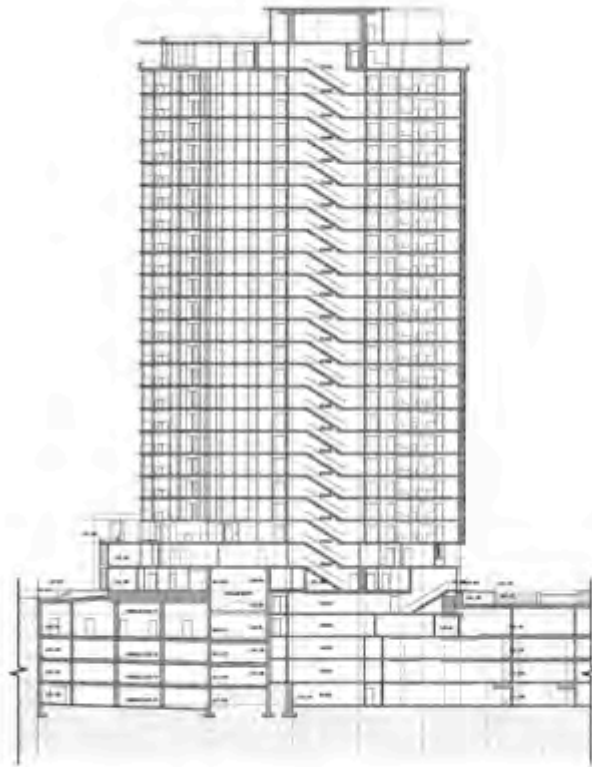
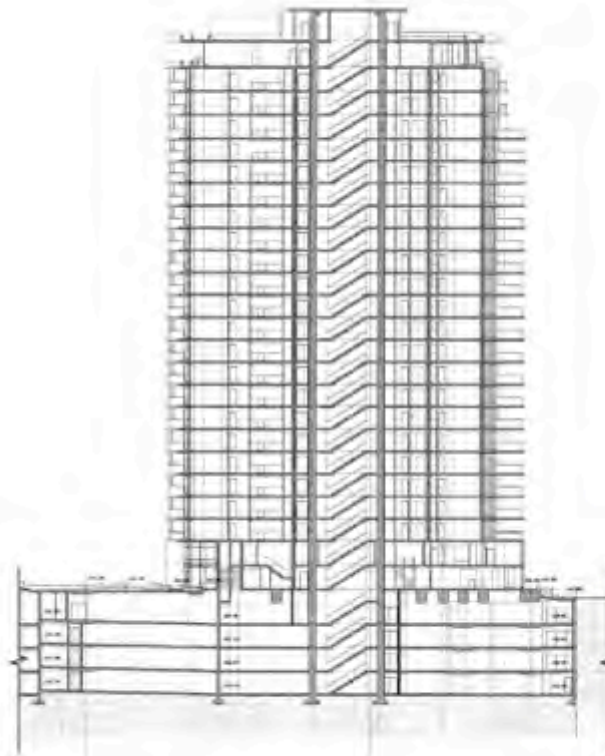
# Site Section

TOWER 6B

TOWER 6D

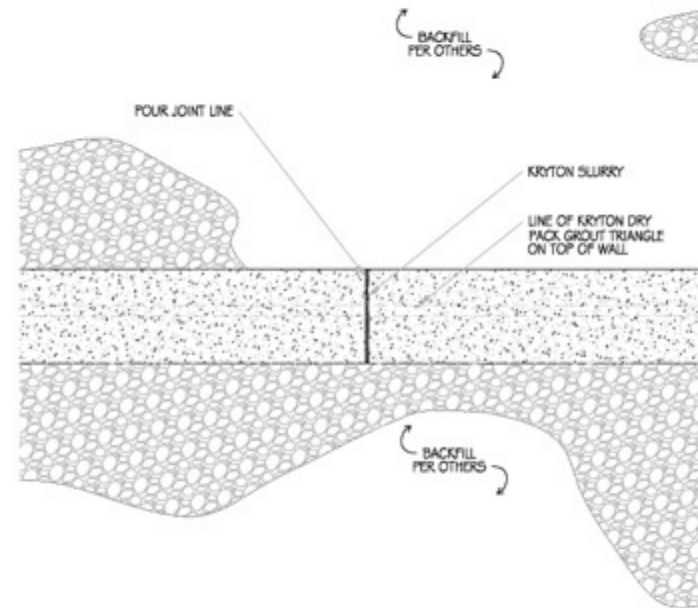
**KIM-1**

CONSTRUCTION JOINT

1 WALL CONSTRUCTION JOINT - BELOW SLAB-ON-GRADE

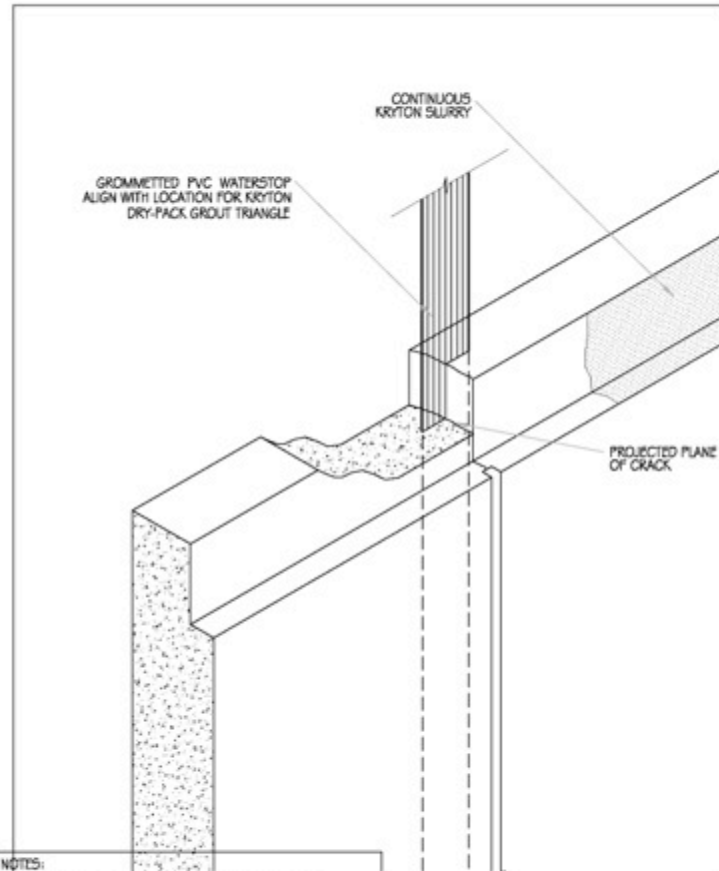
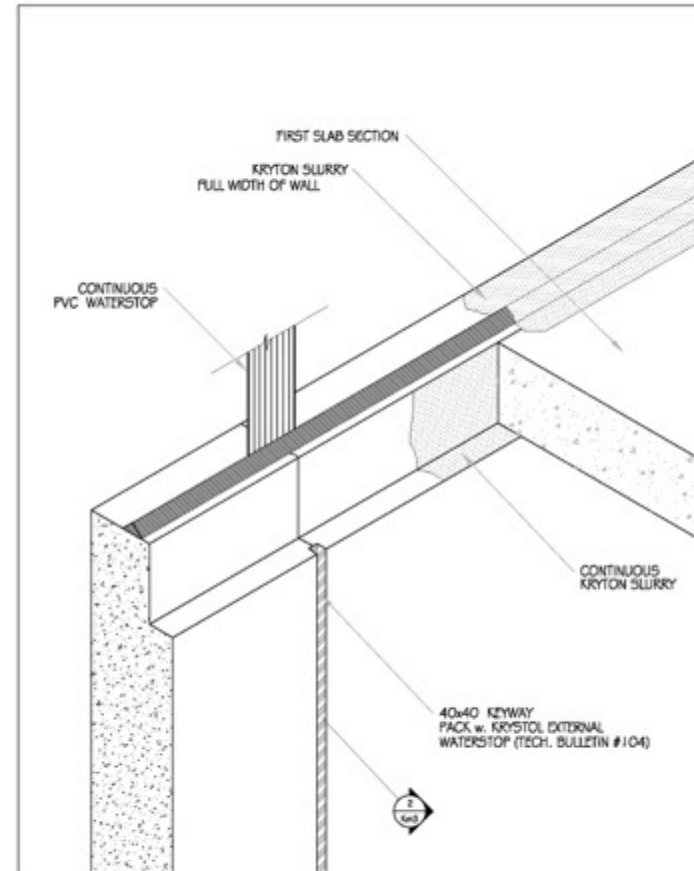
**KIM-4**

DWG TITLE  
WALL CONTROL JOINT AND FIRST SLAB CONFIGURATION

1 KEYWAY AND SLURRY AT WALL CONTROL JOINT

2 GROUT AND SLURRY AT SLAB

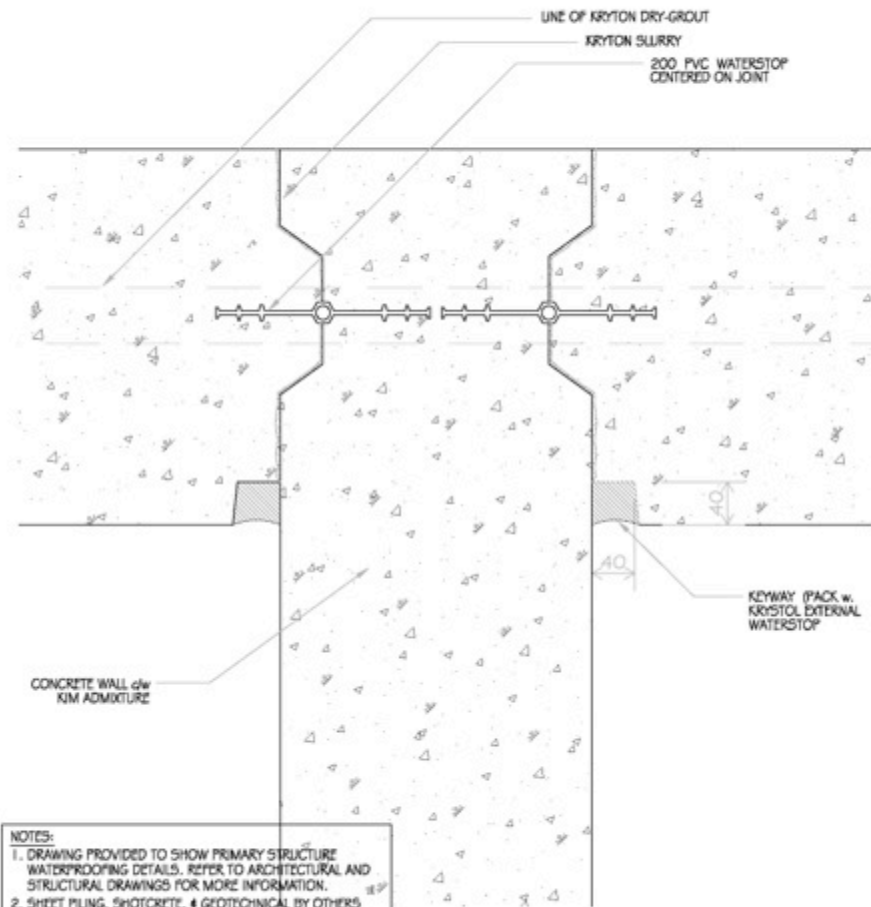
1 WALL CONNECTION AT P4 (NORTH EL., GRID A-B)

SCALE 1:100  
 DESIGNED SKC  
 DRAWN SO  
 REVIEWED JS  
 DWS TITLE  
 CONSTRUCTION JOINT  
 LEVEL XX  
 REVISION  
 DWS NO

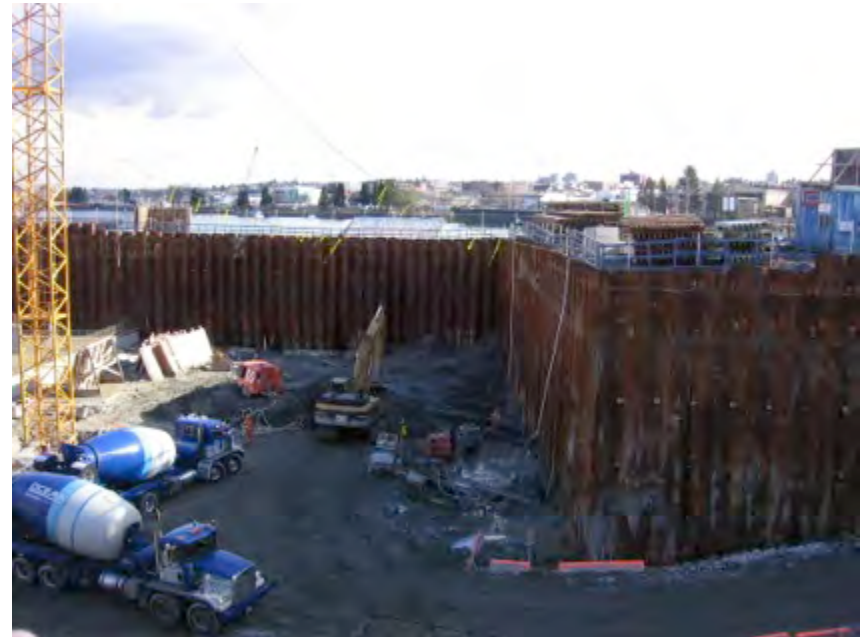
- ✓ Sheet piles utilized to retain soil and moisture for False Creek
- ✓ Lengthy process sequenced so that forming could be ongoing in one hole while excavation was in progress in other areas

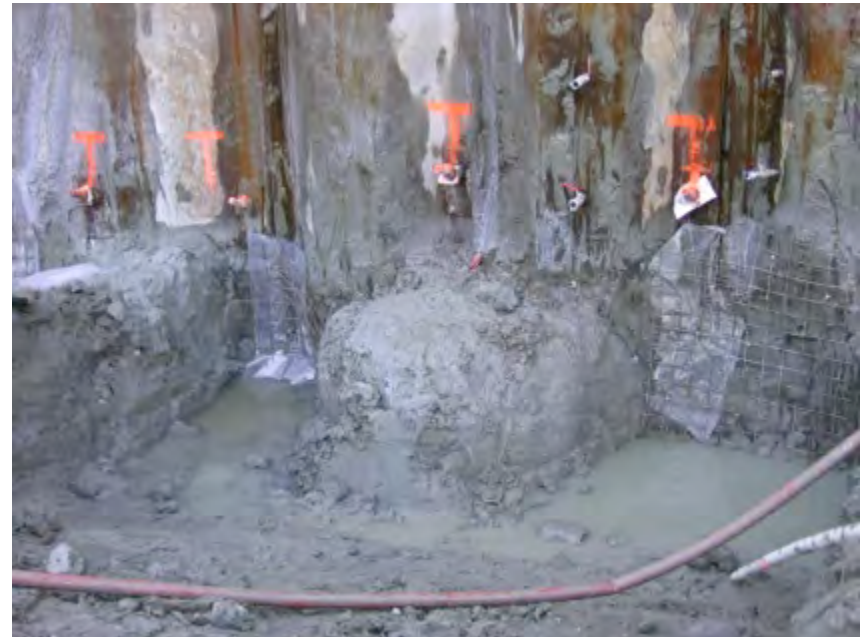
- ✓ Large boulder was found during excavation
- ✓ Impractical to remove boulder
- ✓ Adjustment made to design in consultation with structural engineer to accommodate boulder being left in place

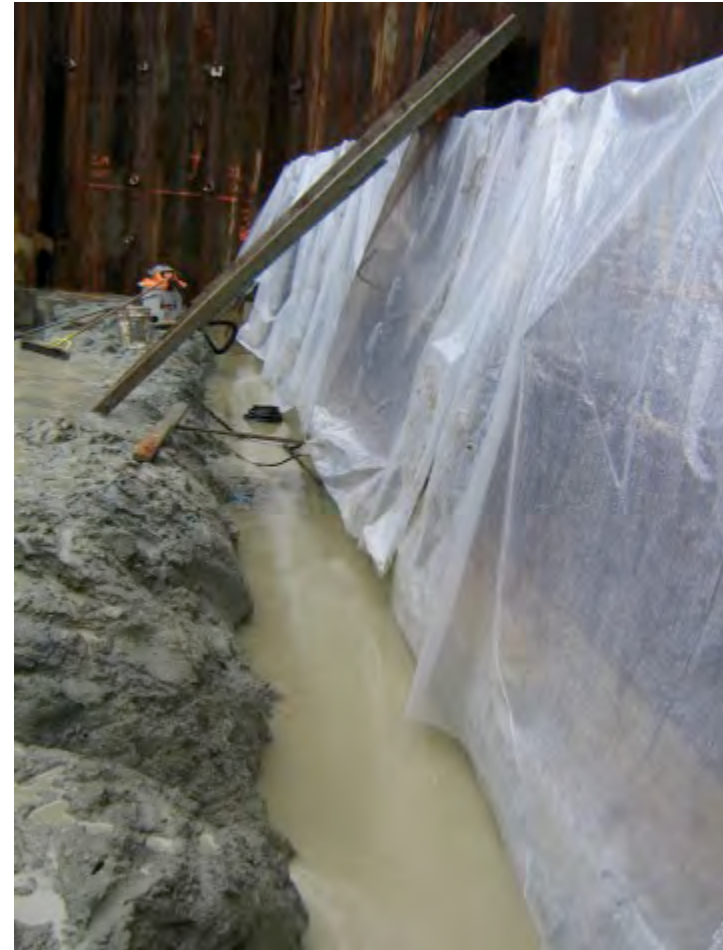
- ✓ Constant de-watering during excavation and forming
- ✓ Mud had to be kept clean from concrete
- ✓ Grout and slurry had to be applied damp and kept dry to cure
- ✓ Tarping required for contractor to apply product in the rain

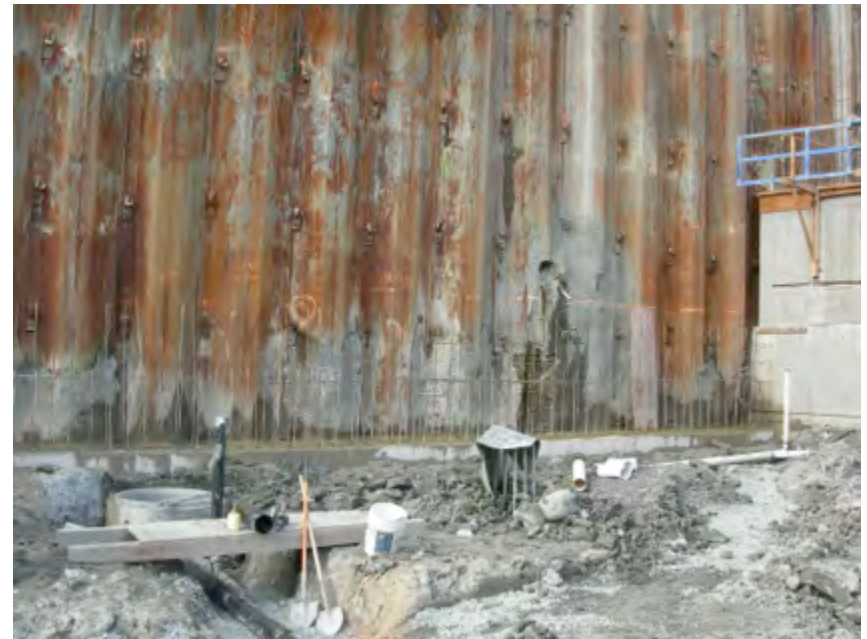
- ✓ Below slab on grade drainage system
- ✓ Footing poured against piles

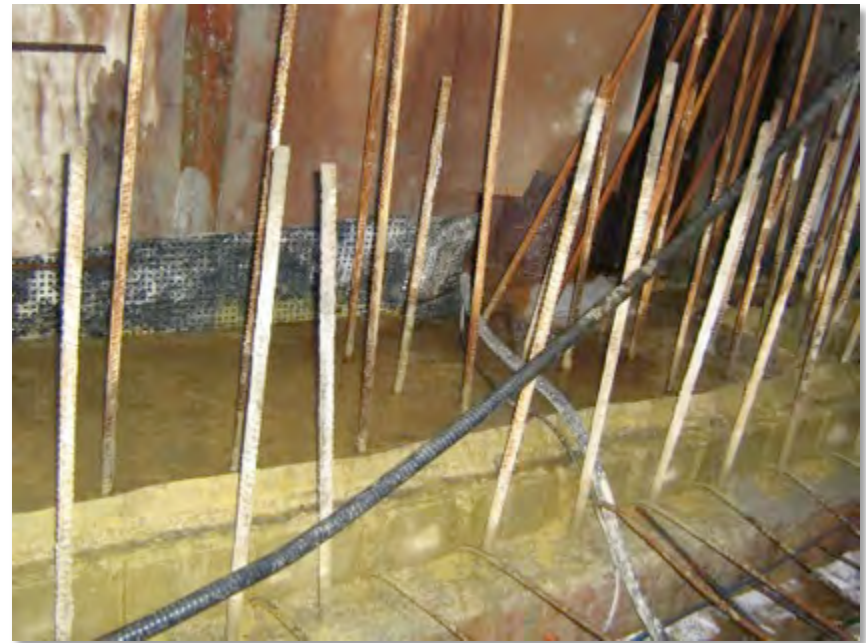
- ✓ Footing wall covered in water
- ✓ During construction, constant de-watering required to install grout and slurry
- ✓ Grout and slurry washed off if exposed to water
- ✓ If washed off, could be re-applied
- ✓ Once cured, was resistant to water

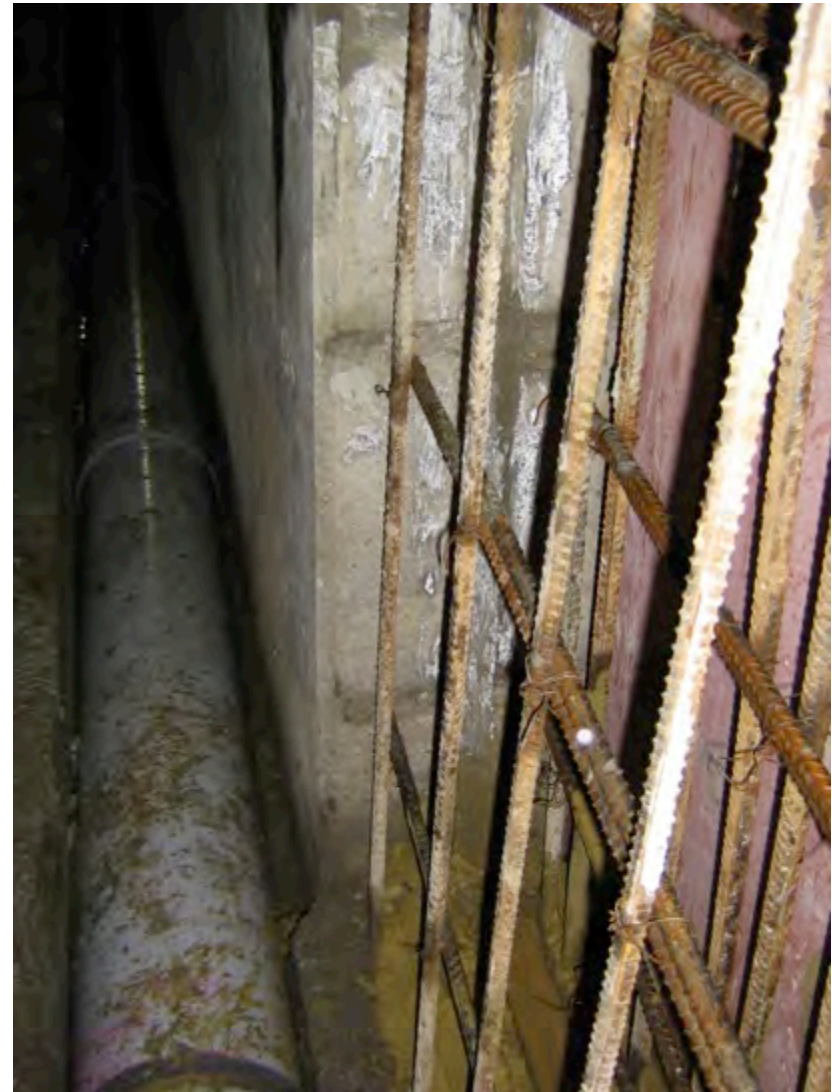
## Perimeter drainage inside pony wall at footing

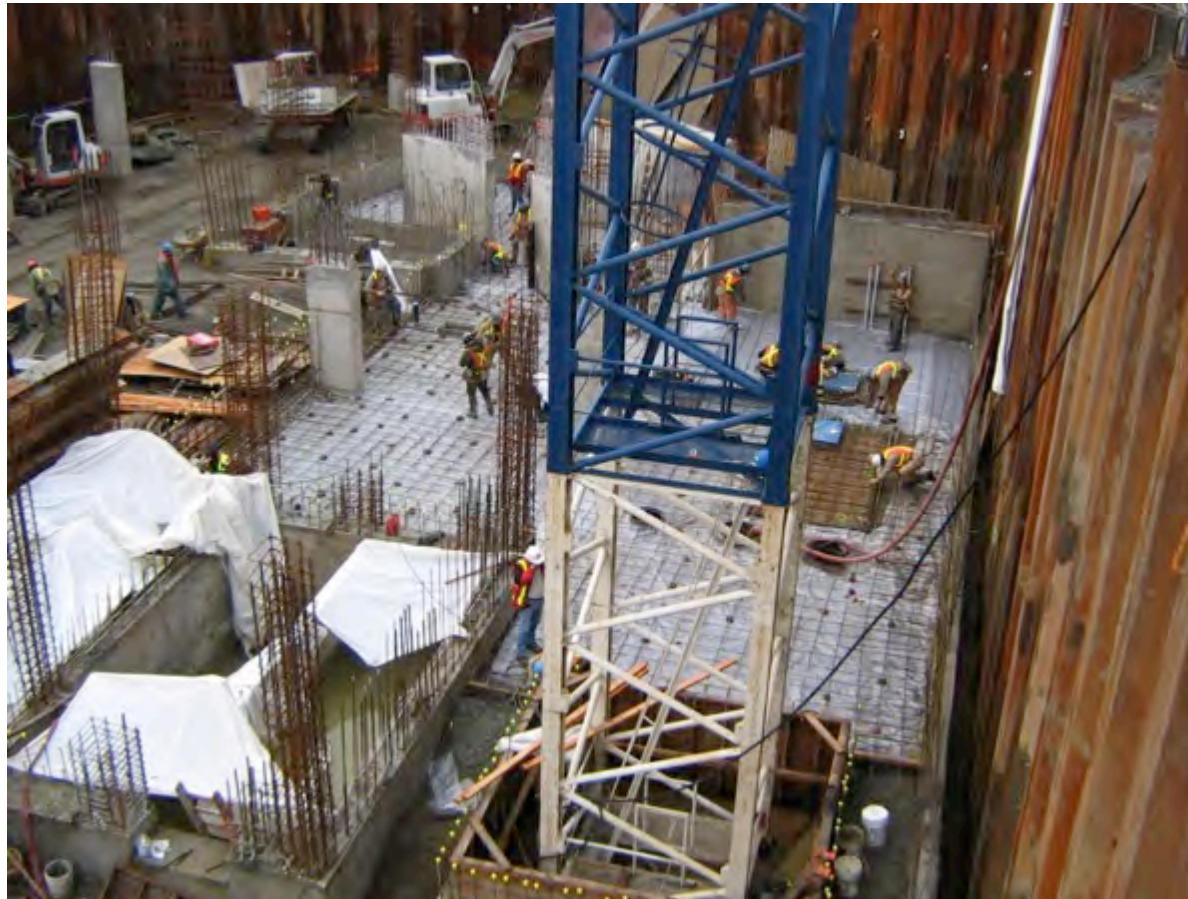
## Slab-on-grade at lowest level

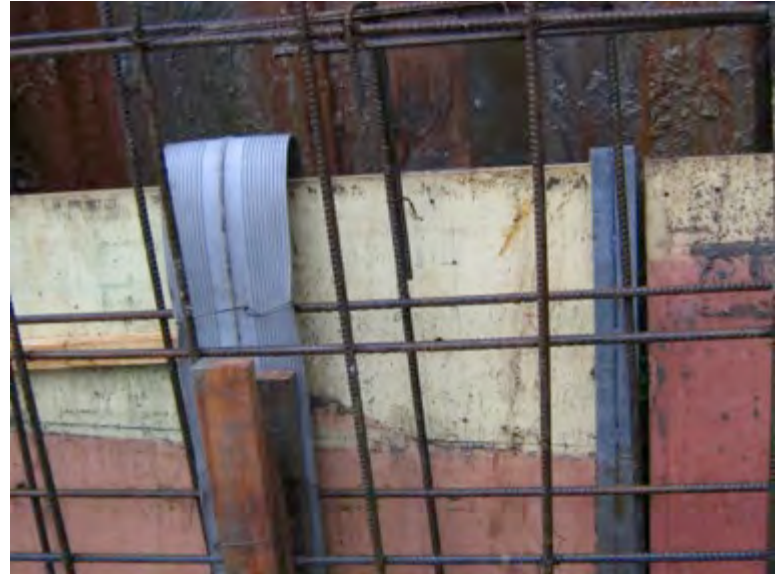
- ✓ PVC water stops fastened to reinforcing steel
- ✓ Difficulty keeping PVC water stop in place during pours
- ✓ Water stops dislodged during pour become ineffective
- ✓ Water stops used in addition to keyways for grout to be applied later
- ✓ Grout and slurry at vertical provided second line of defence against water penetration at vertical joints

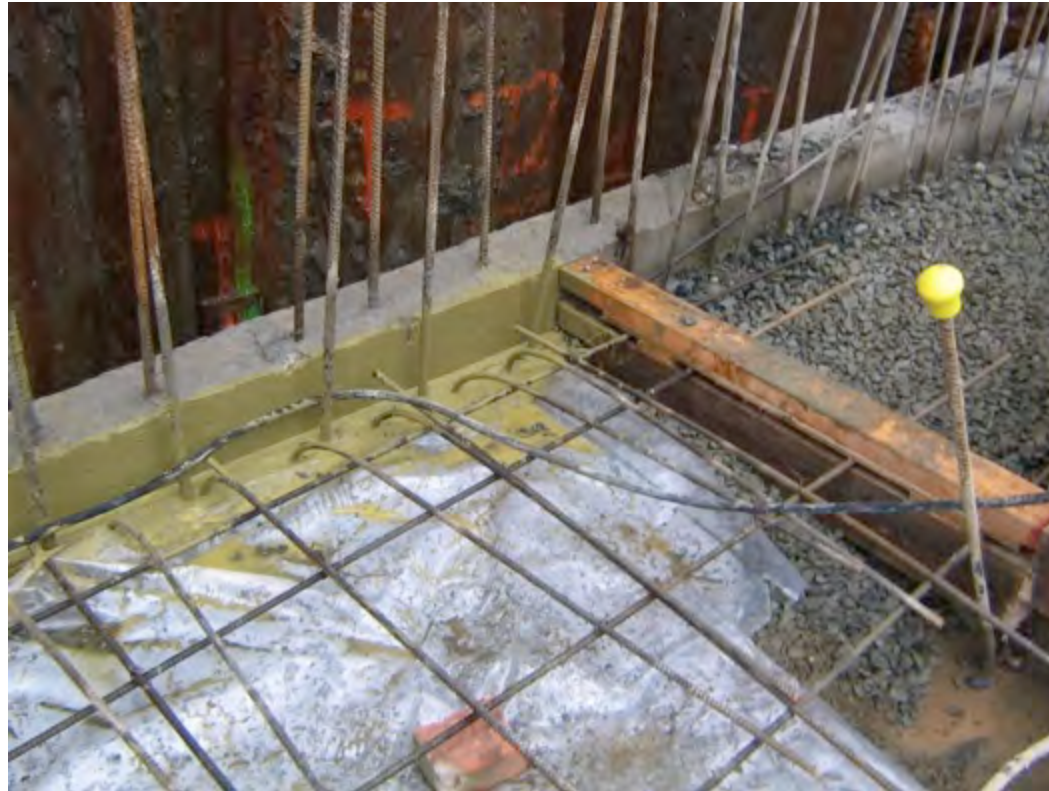
**Gravel and polyethylene sheet  
installed below slab on grade**

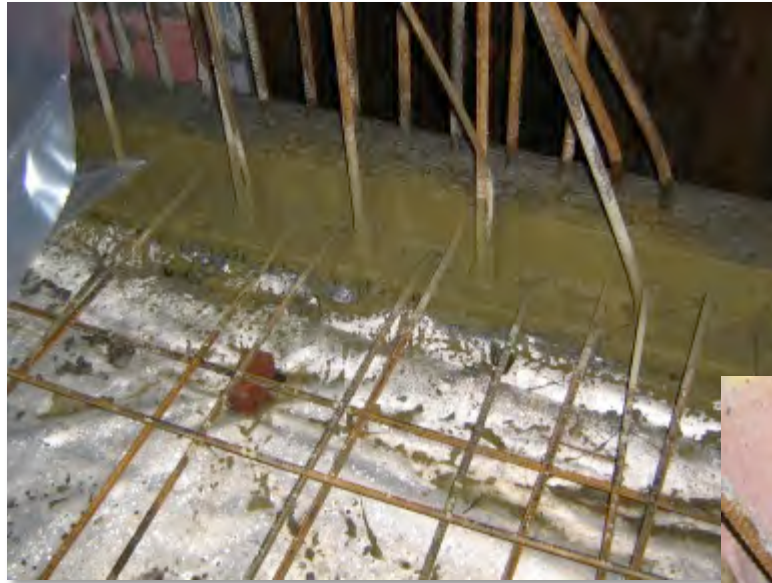
**Slurry applied to pony wall transition prior to pouring slab on grade**

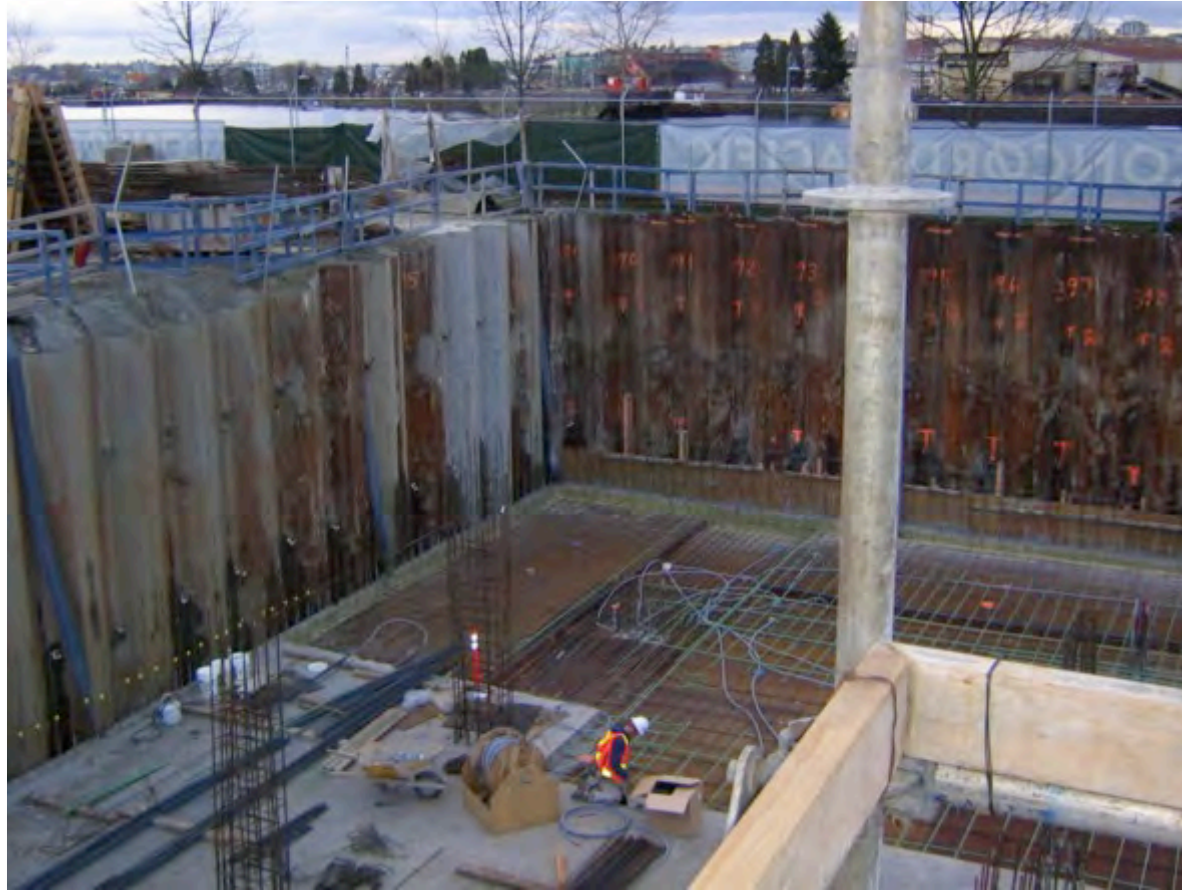
## Typical suspended slab forming

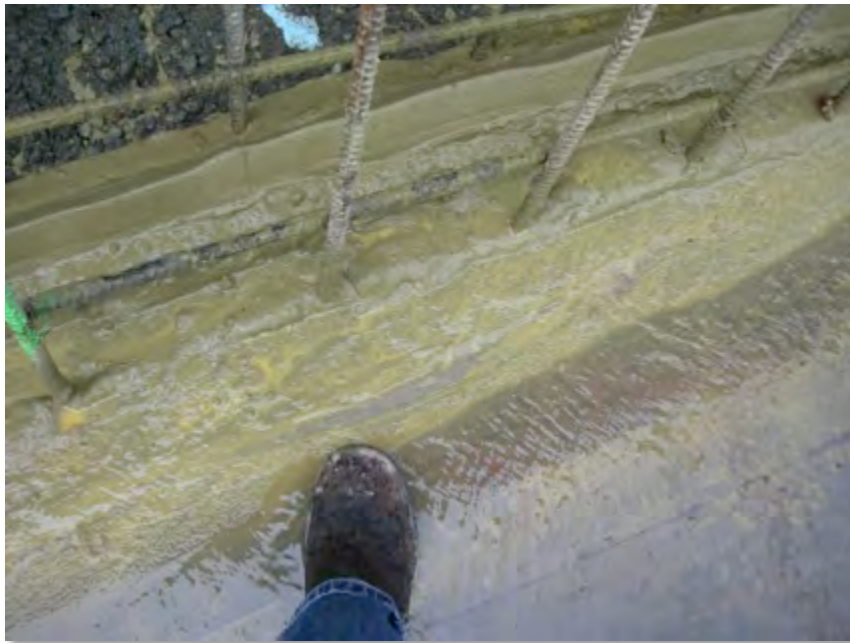
- ✓ Key in foundation wall formed to receive slab
- ✓ Key coated with slurry only
- ✓ Kryton admixture in foundation wall covers slab edge

- ✓ If wetted, slurry would wash off and had to be re-applied

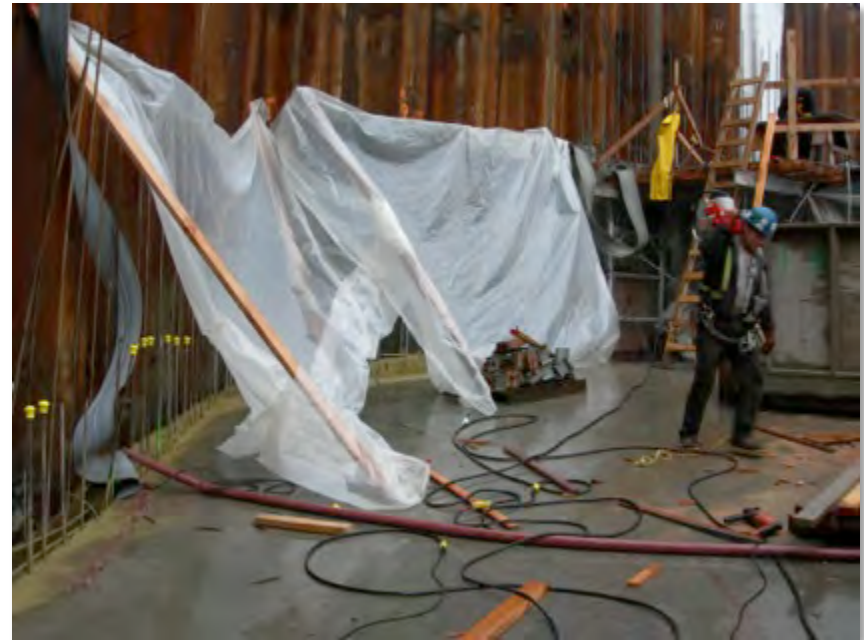
- ✓ Tarping was often used during application of grout and slurry
- ✓ Once fully set, grout and slurry could be exposed to weather

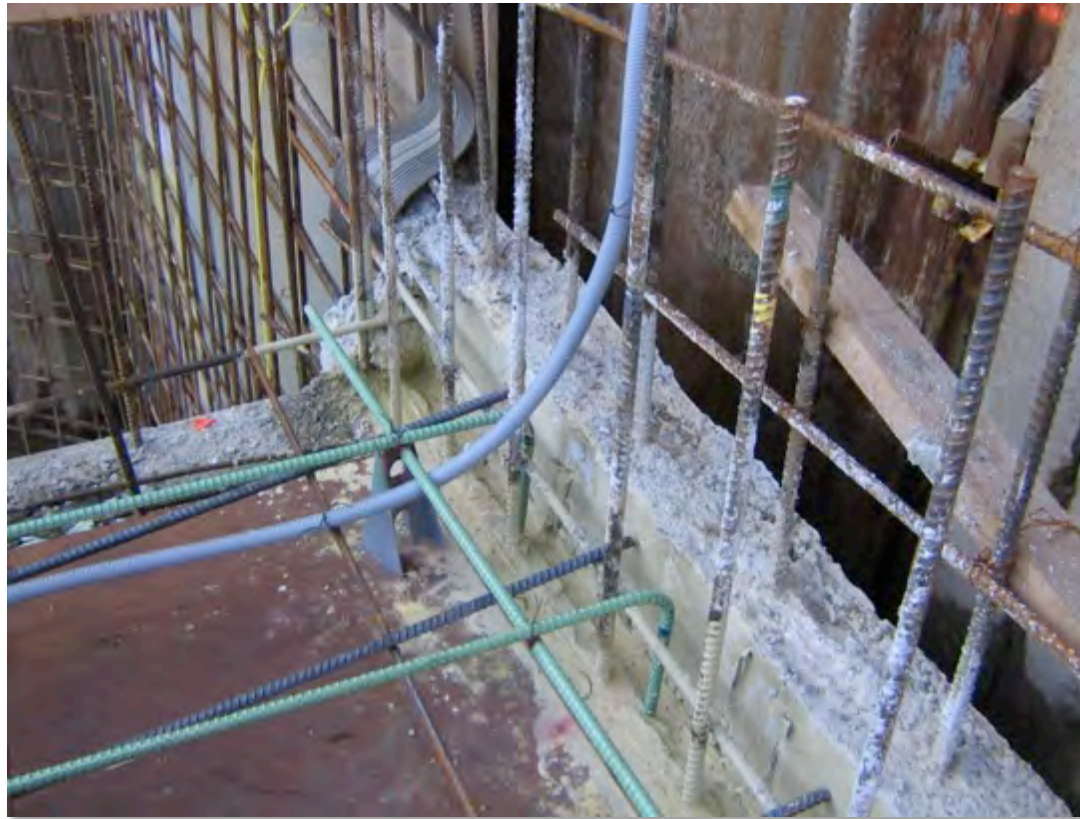
## Reinforcing steel at suspended slab hooked into steel at wall

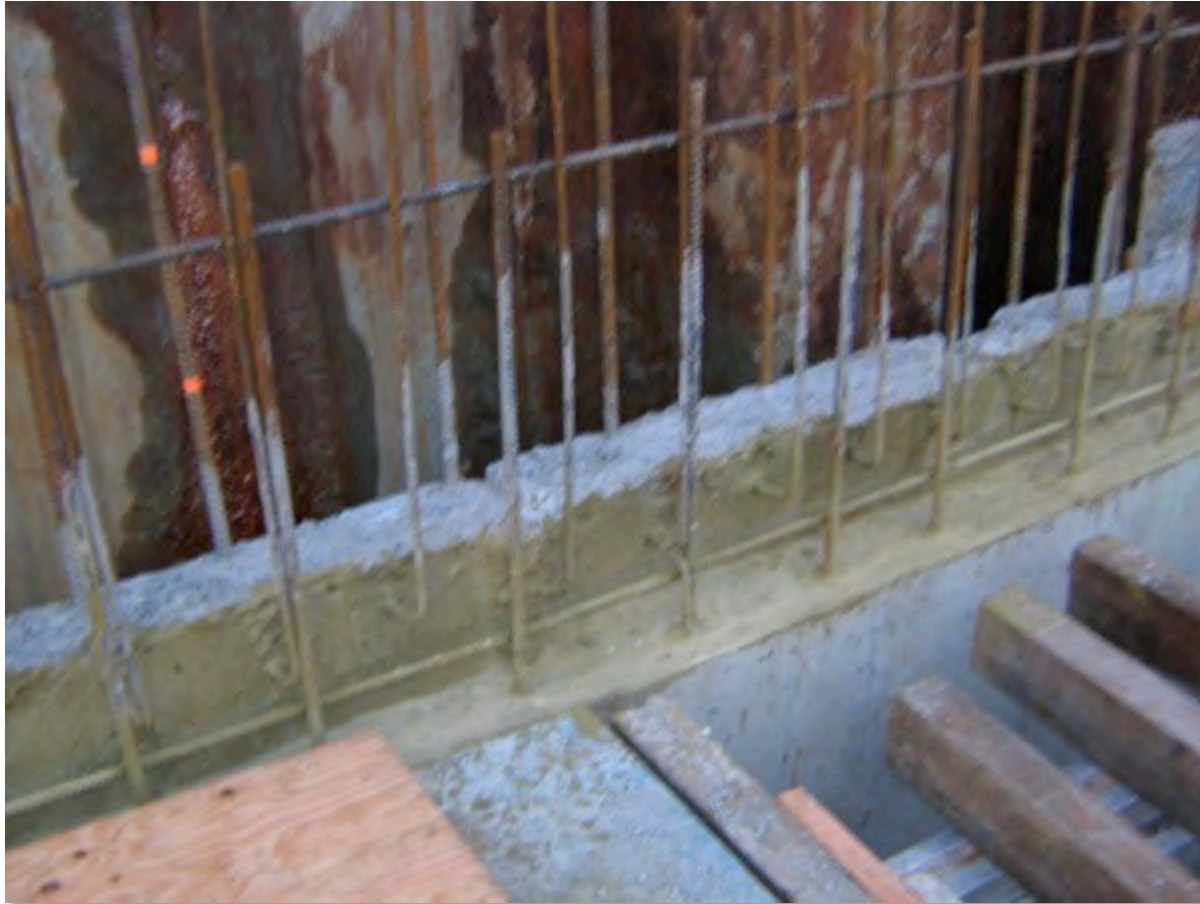
## Suspended slab forming

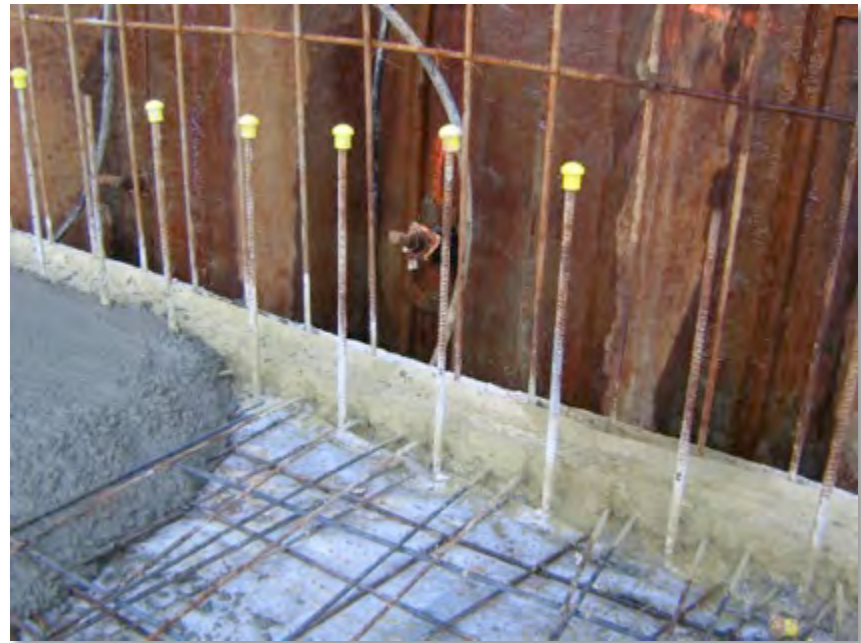
- ✓ Suspended slab poured onto shelf of foundation wall
- ✓ Minimizes exposed cold joints to one rather than two in conventional forming practices

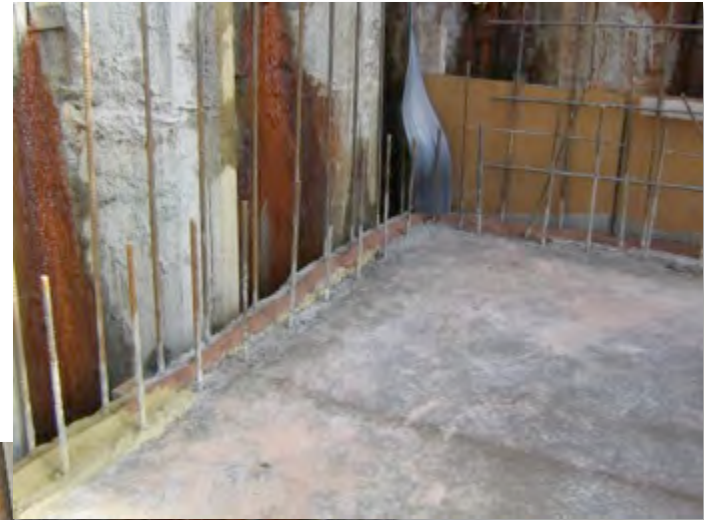
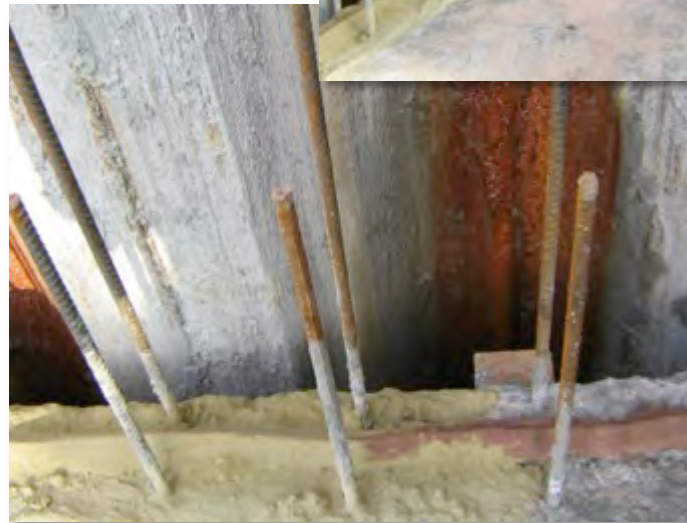
- ✓ Grout triangle placed onto damp foundation wall
- ✓ Once cured (several hours) slurry can be applied

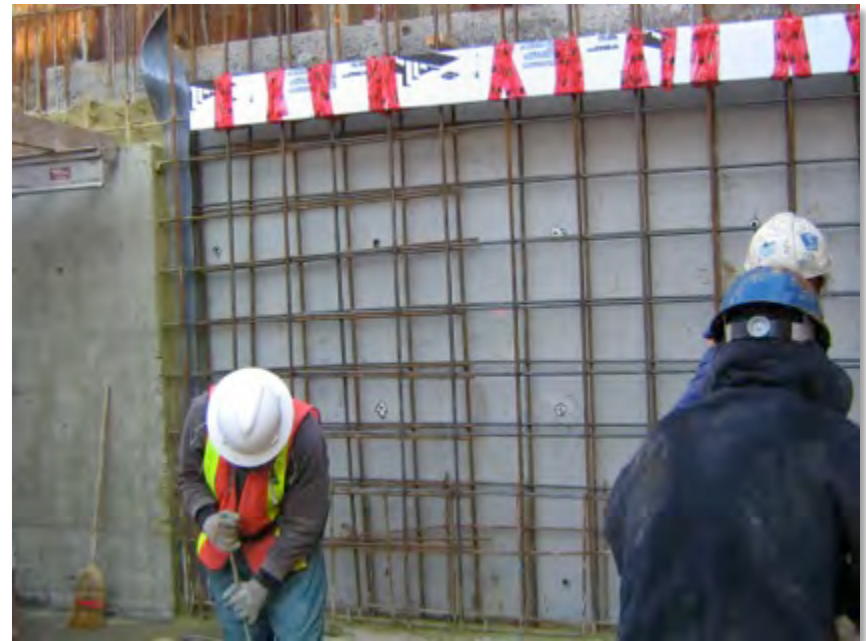
- ✓ PVC water stop and slurry at vertical joints
- ✓ Keyway left for grout at a later date

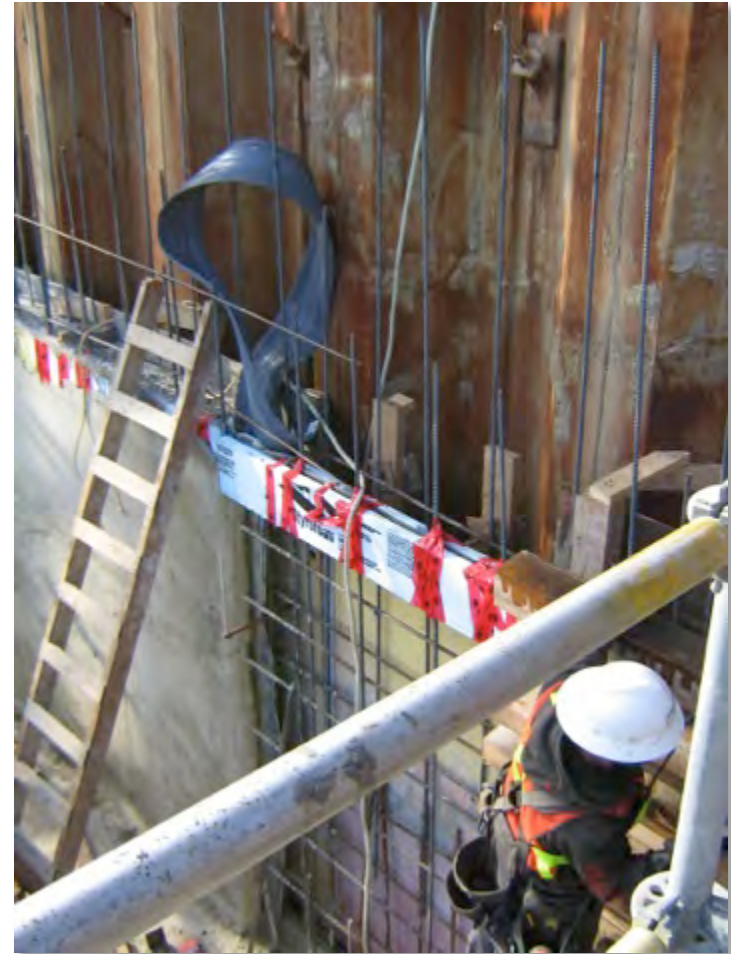
- ✓ PVC water stop was continuous from floor to floor

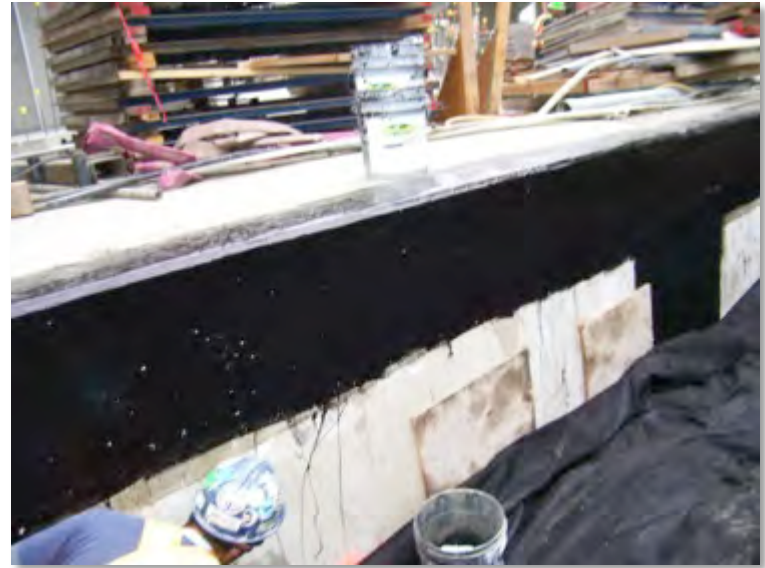
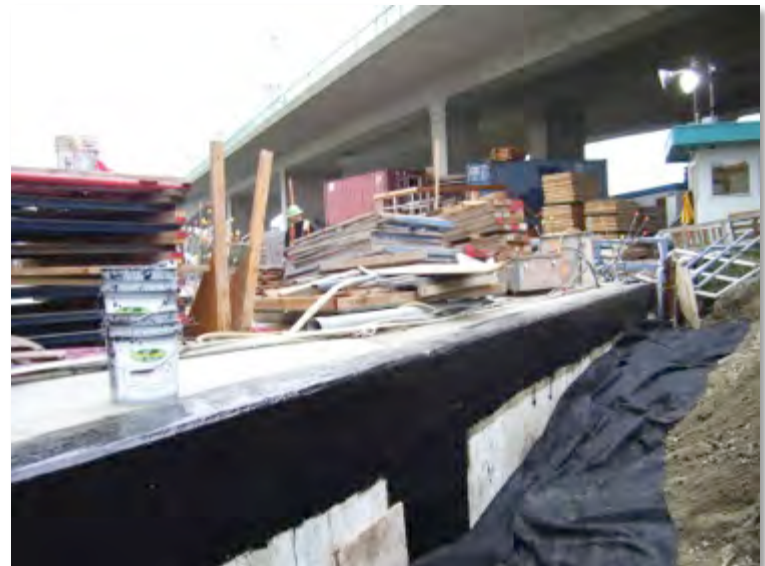
- ✓ Cutting of piles required to perform membrane tie in over slab edge
- ✓ For this project, asphalt modified urethane was selected
- ✓ Backfilled once membrane installation complete

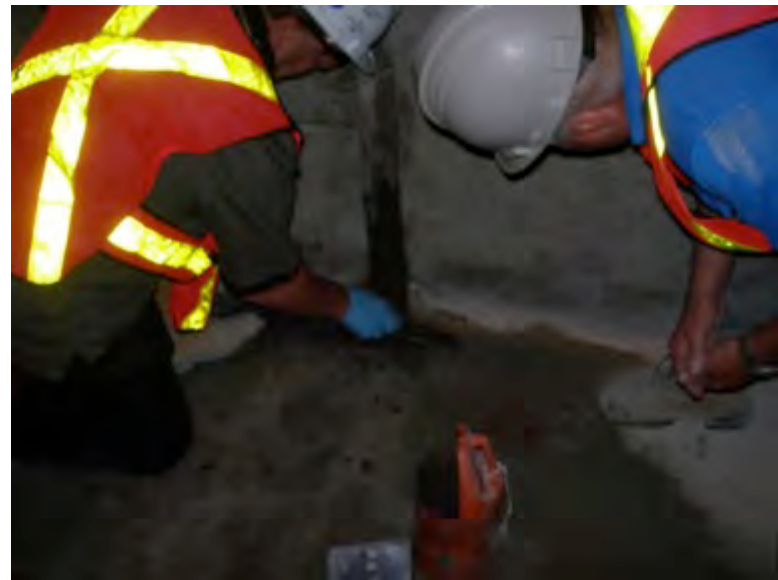
- ✓ Many cracks and leaks remained before and after occupancy.
- ✓ Some leaks were patched and leaks continued
- ✓ Developer wanted to wait as long as possible to repair cracks to minimize the risk of new cracks occurring and allow self-sealing capabilities to work as much as possible

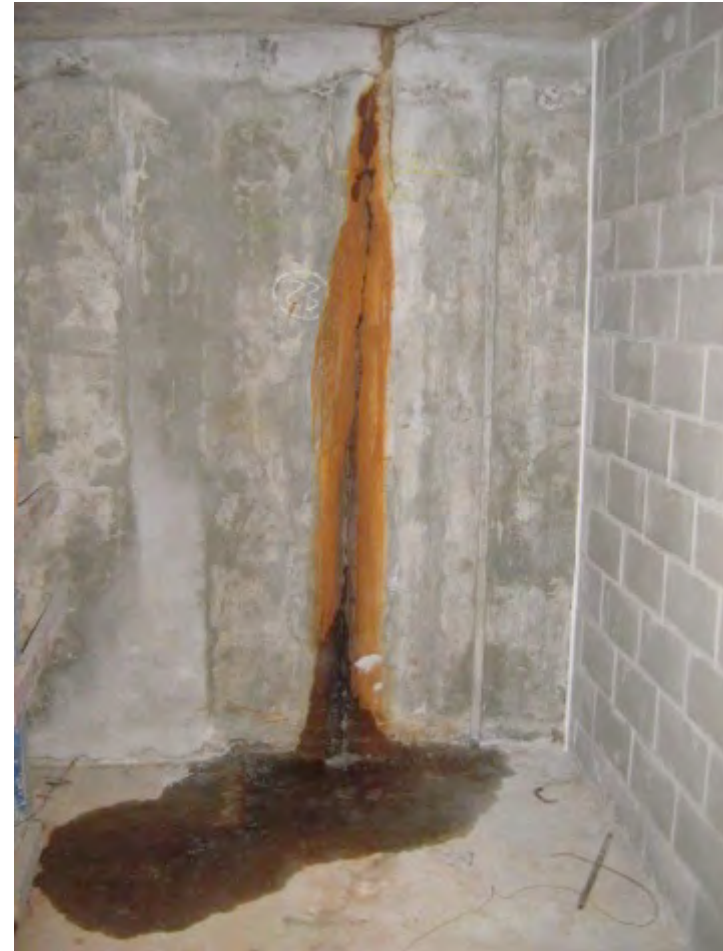
- ✓ 2006 parking garages complete
- ✓ Initial survey found more than 40 leaks
- ✓ Some initial crack repair was conducted
- ✓ Leaks continued as construction of structure progressed and concrete cured

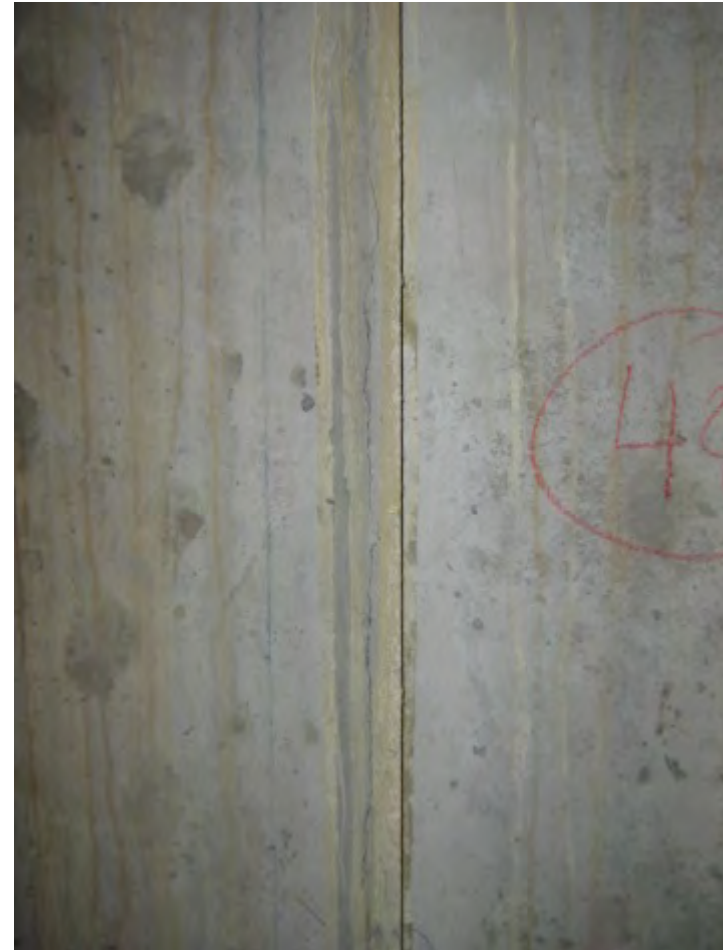
- ✓ Cracks and leaks were generally located at control joints

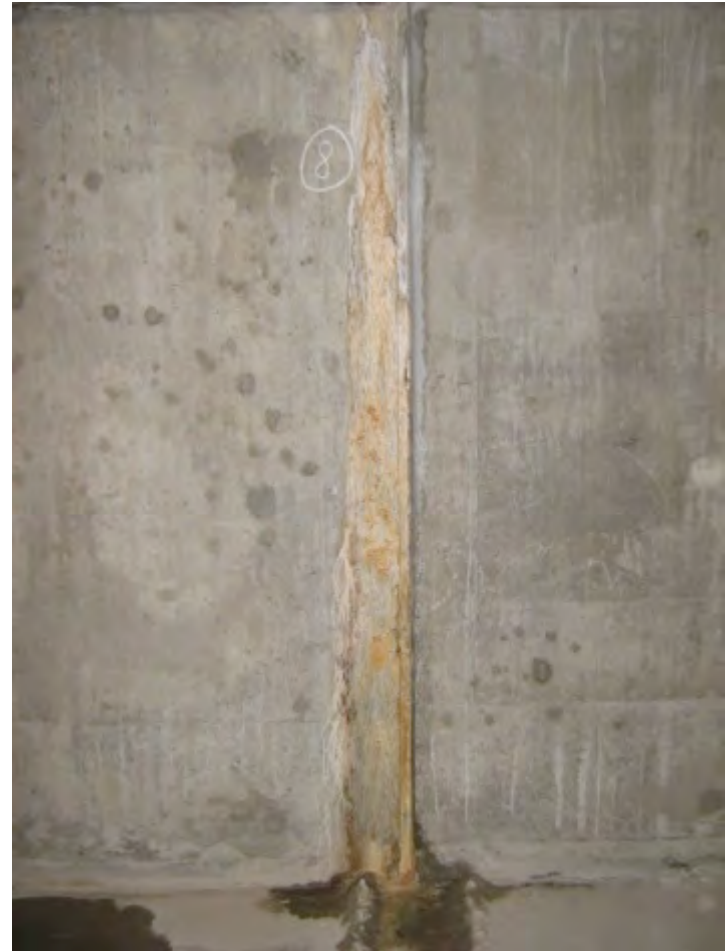
- ✓ Cracks also occurred:
  - Adjacent to control joints
  - At changes in wall thickness
  - Base of wall

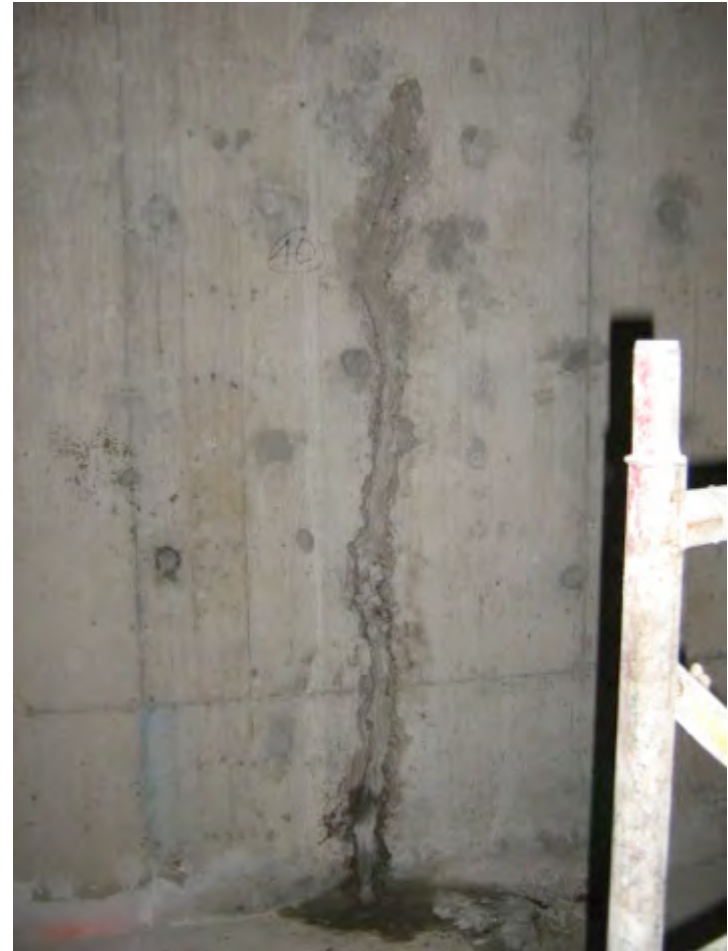
- ✓ Some cracks initially repaired continued to leak
- ✓ In some instances, the original repairs were not carried out according to manufacturer's recommendations

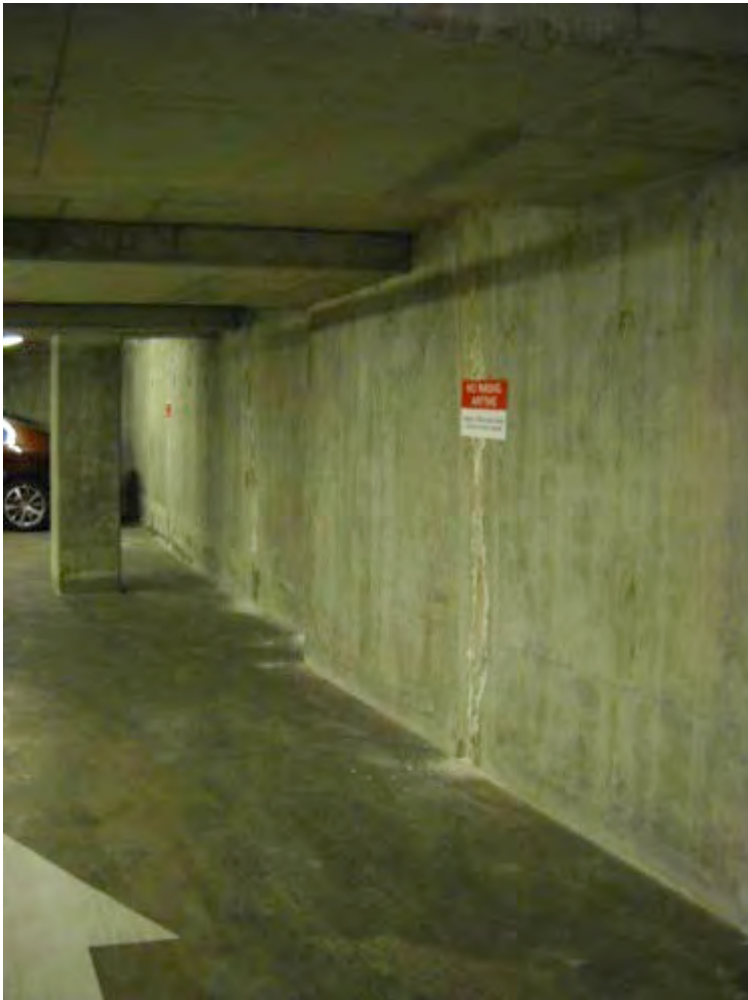
- ✓ Signs of crystal growth were noted in more than 20 areas during 2010 warranty review
- ✓ No active leaks were observed
- ✓ Red flags were raised by Strata due to their lack of understanding or belief in the system
- ✓ Third party retained by Strata to review leaks
