**RCI Western Canada Chapter  
Fall Waterproofing Seminar  
October 27, 2011**

# **“Integral Waterproofing”**

Case-study of a large high-rise project in False Creek in Vancouver, BC.

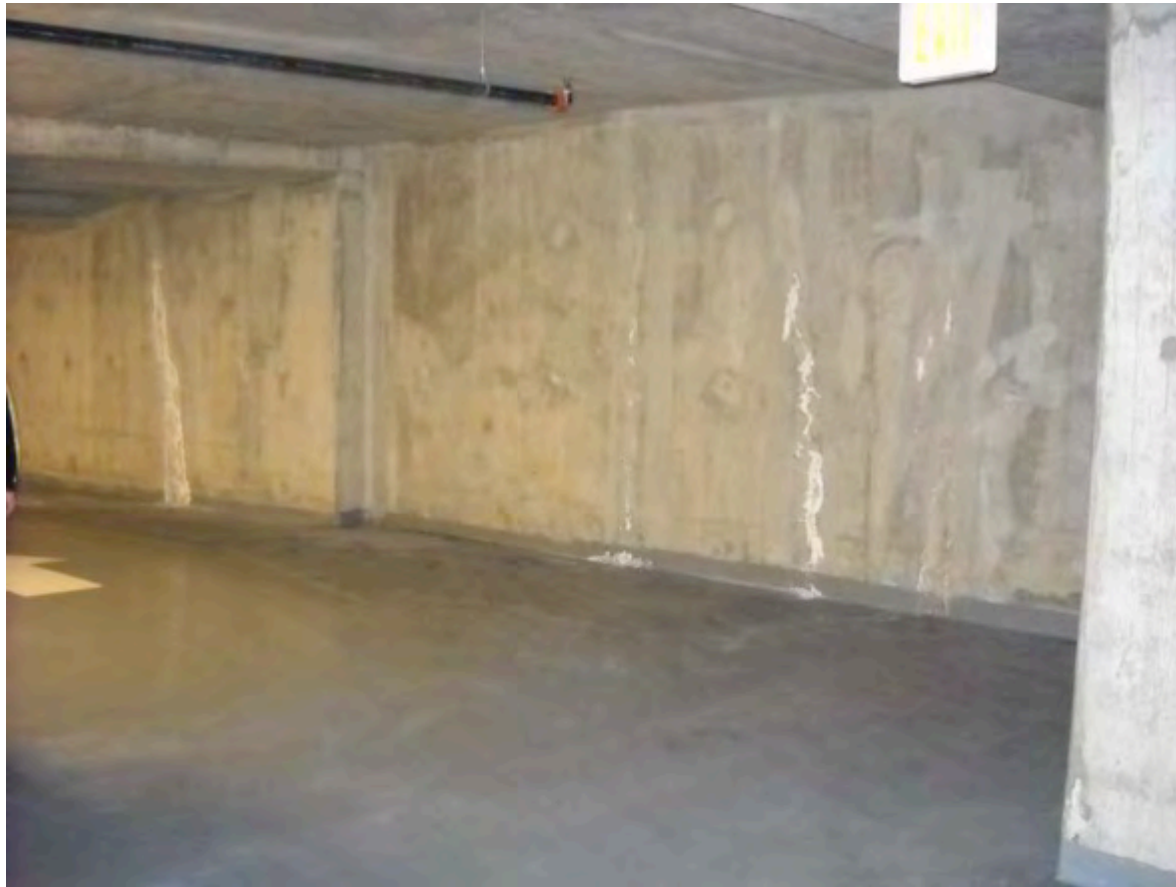
## Krystol residue after 2010 warranty review
