RCI Western Canada Chapter 2012 Winter Seminar

Single-ply Membrane Sloped Roof Retrofit

Presentation by
Guillaume Vadeboncoeur, P.Eng, LEED AP

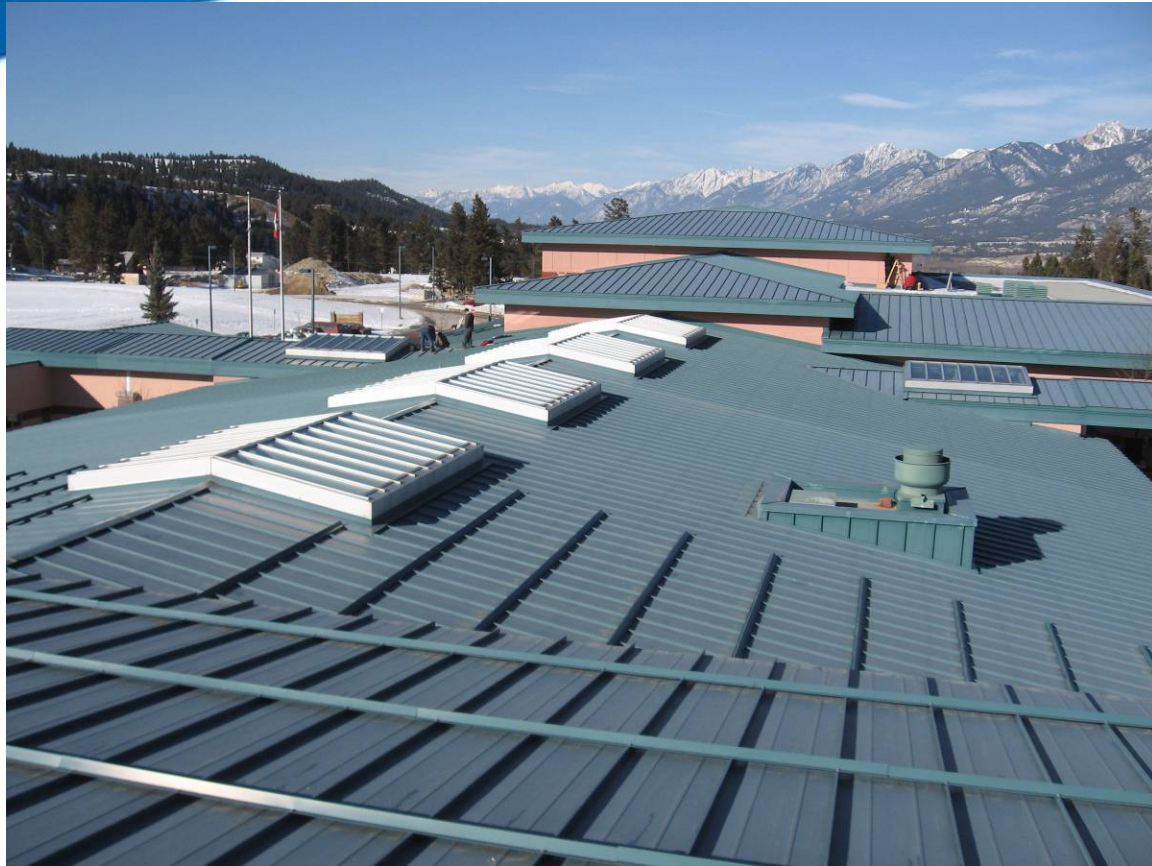
Water appeared to penetrate past the metal panels at the following locations:

- Roof crickets
- Skylight details,
- Eave (ice damming)
- Through the standing seams at the eave.

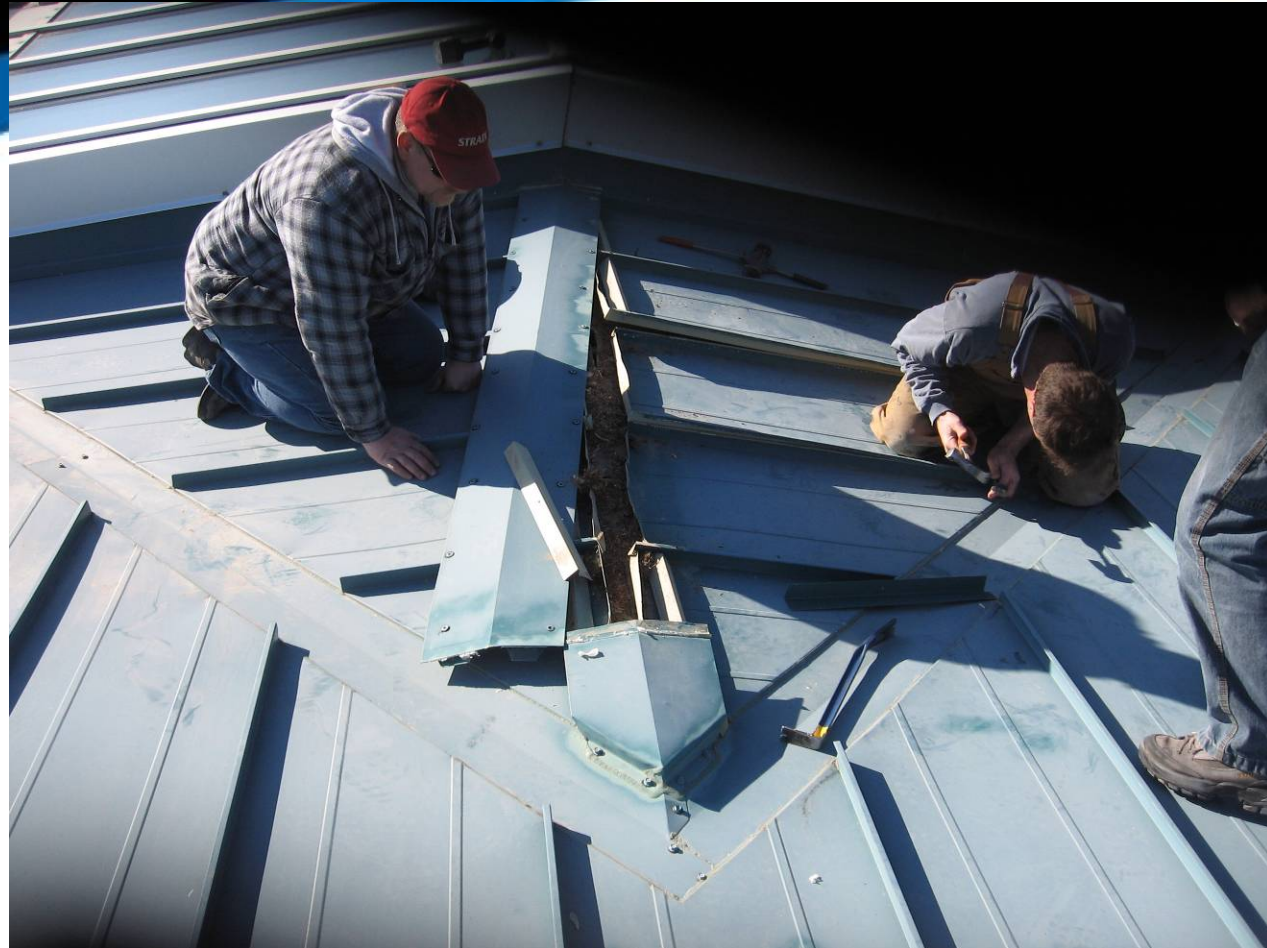
- The metal panels were corroded at several locations. Temporary repairs were performed throughout the years as the top surface of the panels was corroding at some locations.

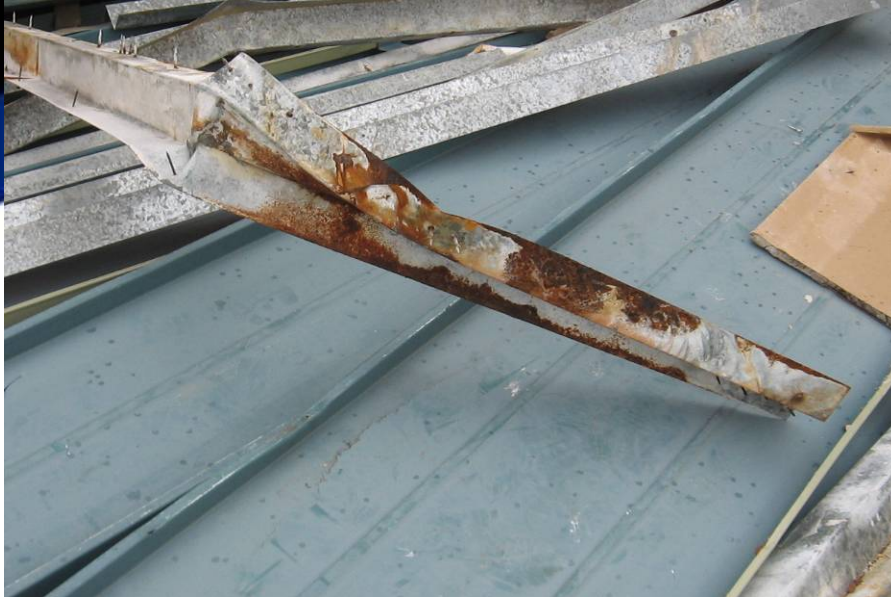
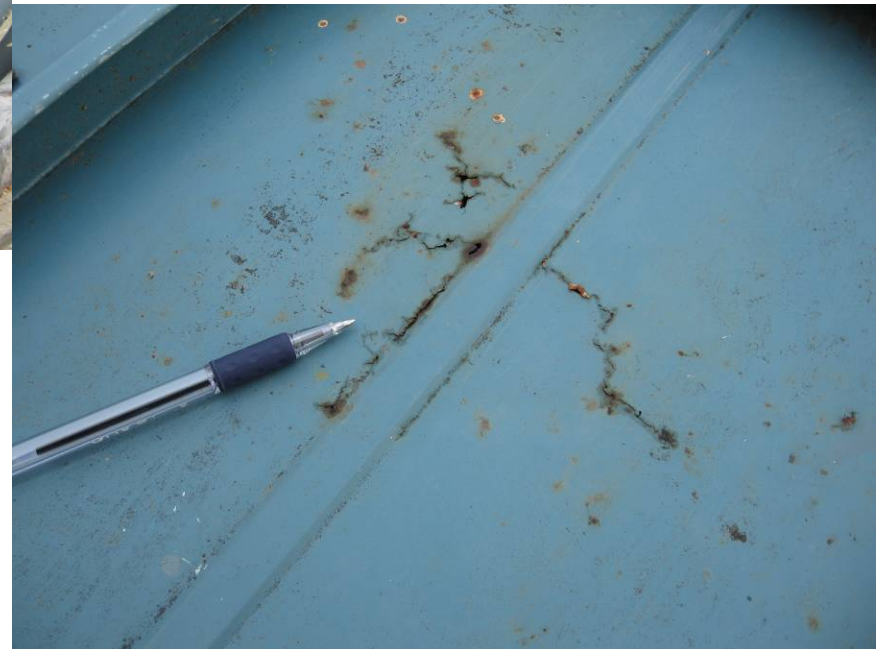
- During the demolition:
- It was discovered that the metal decking was not corroded. The existing vapour barrier (SAM) had protected the decking. The corrosion was limited to the girts and mainly the metal roof panels.
