ROOF DECK CONSIDERATIONS AND CASE STUDIES

Vancouver, May, 11, 2018

Jerry Abendroth, RCC, RWC, REWC, RBEC, RRO, CDT

Roof Deck Discussion
Related Case Studies

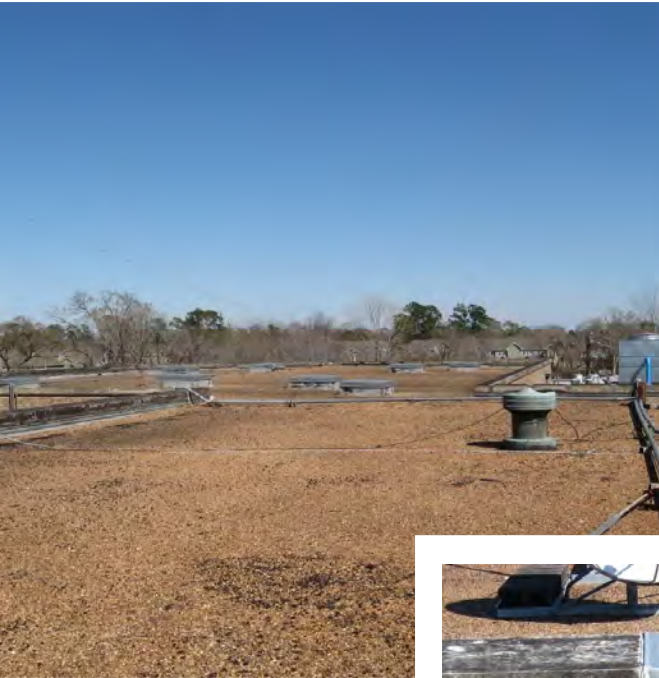
- ▶ Deteriorated brick parapet walls
- ▶ Open expansion joints
- ▶ Deteriorated roof top equipment that had to be replaced

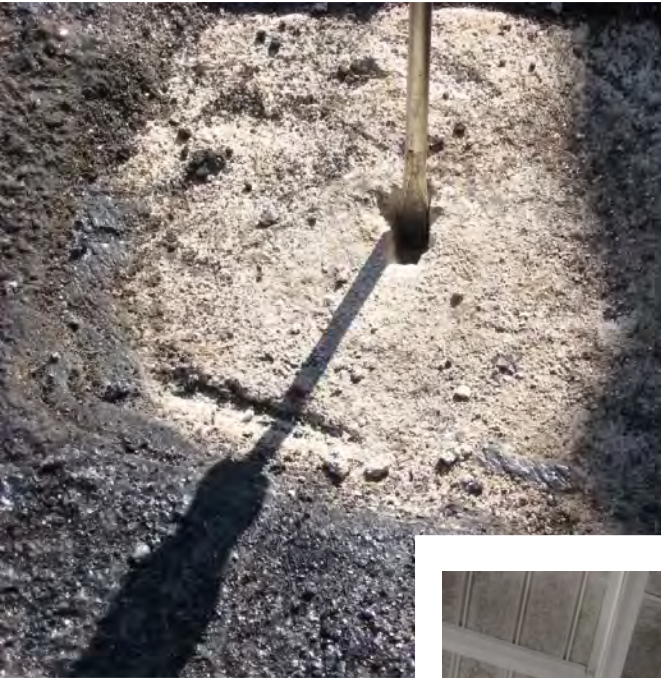
- ▶ Poured-in-place lightweight concrete deck
- ▶ Gypsum plank deck
- ▶ Tectum plank deck

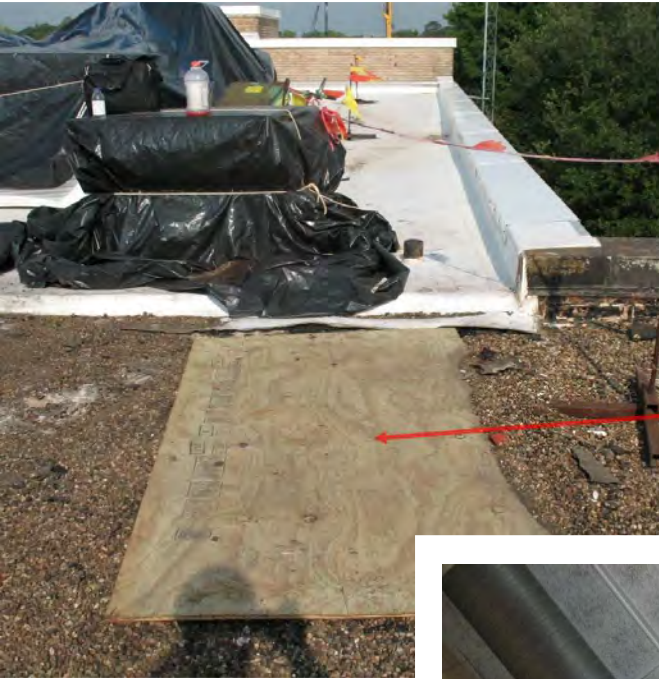
- ▶ On the first several decks, the workers were protected properly.
- ▶ On the gymnasium roof deck, a “soft area” was discovered, marked, and covered with plywood.
- ▶ The plywood was moved during demolition and the area was exposed.
- ▶ One of the workers fell through the “soft area” and was badly injured.

- ▶ Safety is always the responsibility of the General Contractor and subcontractors. Safety can and must be included in the project documents, however, specific issues should not be addressed by the Architect/Engineer/Consultant.
- ▶ Just as the school had to decide whether to demolish the school and rebuild, or to renovate, the Architect/Engineer/Consultant team had to make that same decision for deteriorated roof decks.
- ▶ All of the roof decks should have been completely removed and replaced.

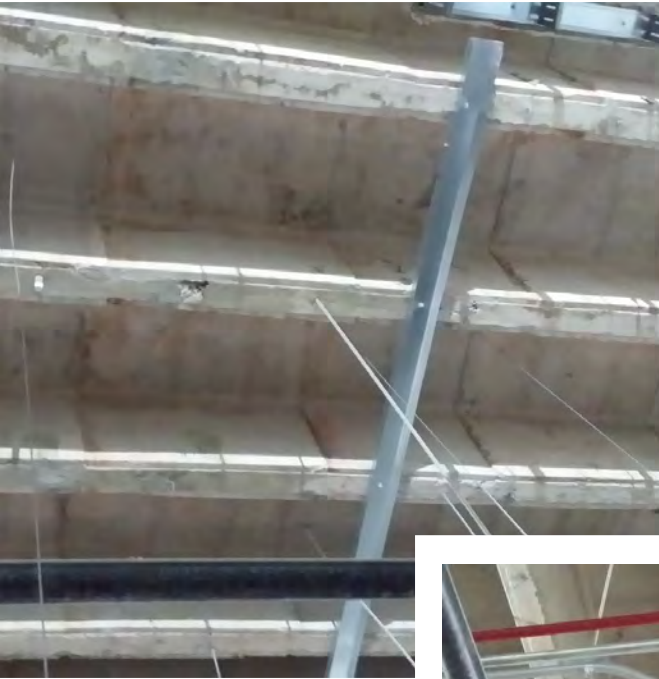
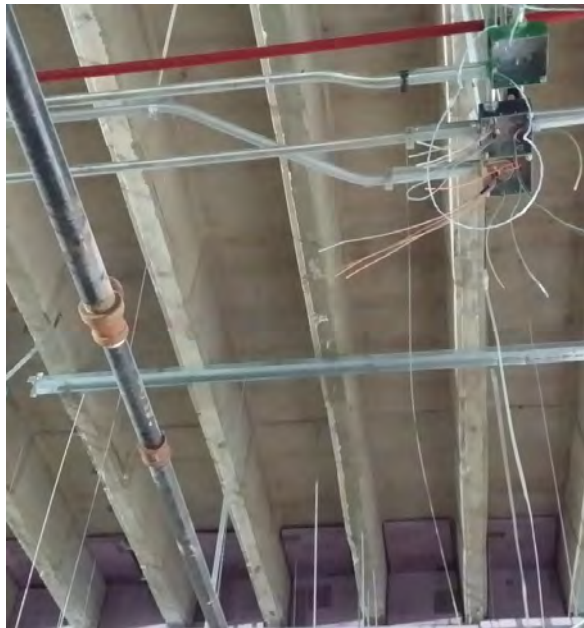
- 2" (5.08 centimeters) concrete roof deck
- 36" (.91 meters) x 6" (15.24 centimeters) concrete beams 48" (1.22 meters) on center

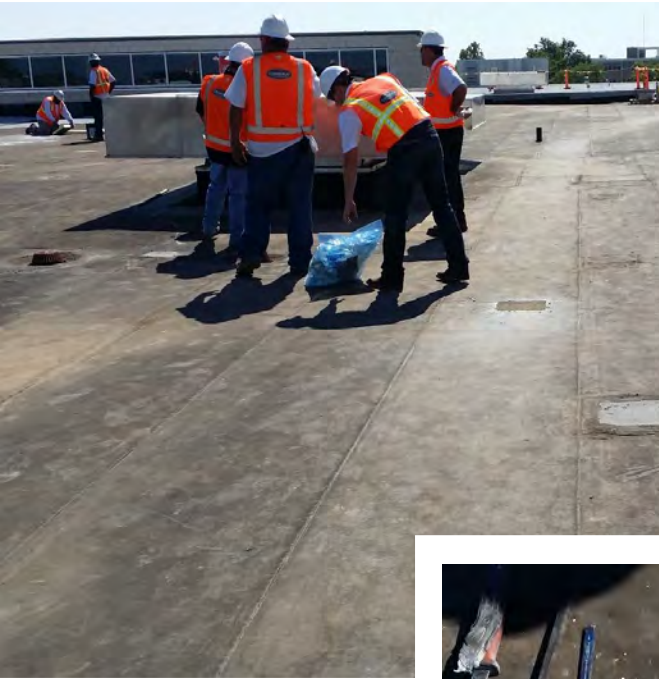
- Test cuts revealed condensation between the concrete roof deck and the first layer of insulation.

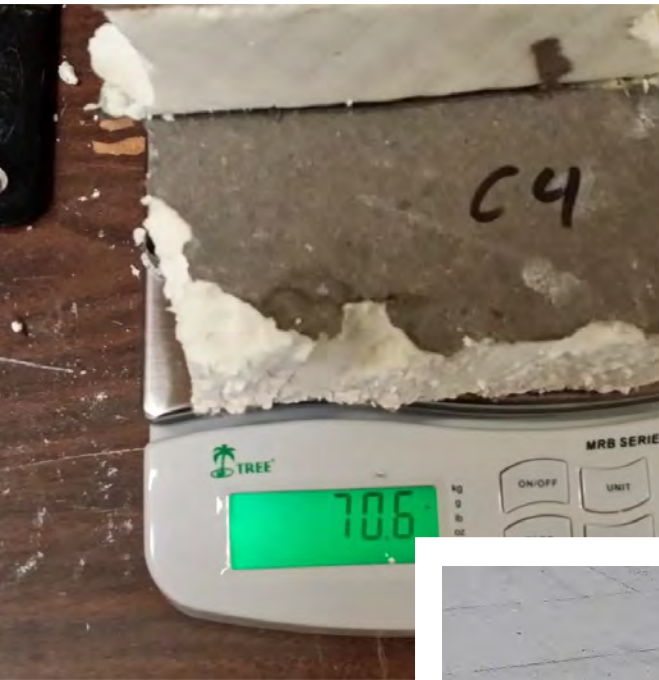
- Gravimetric testing was employed to evaluate before and after moisture content by weight

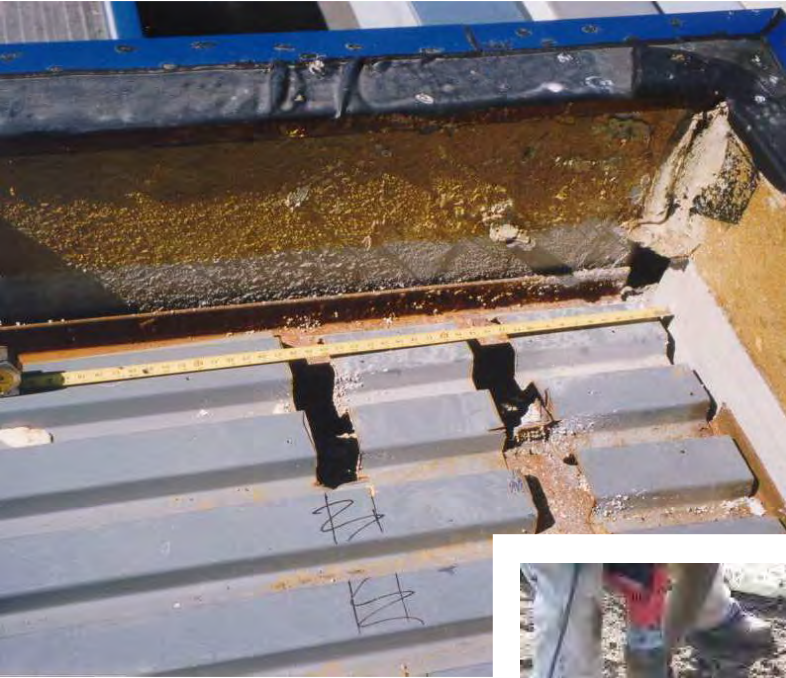
DECK INSPECTIONS

CORROSION PROBLEMS

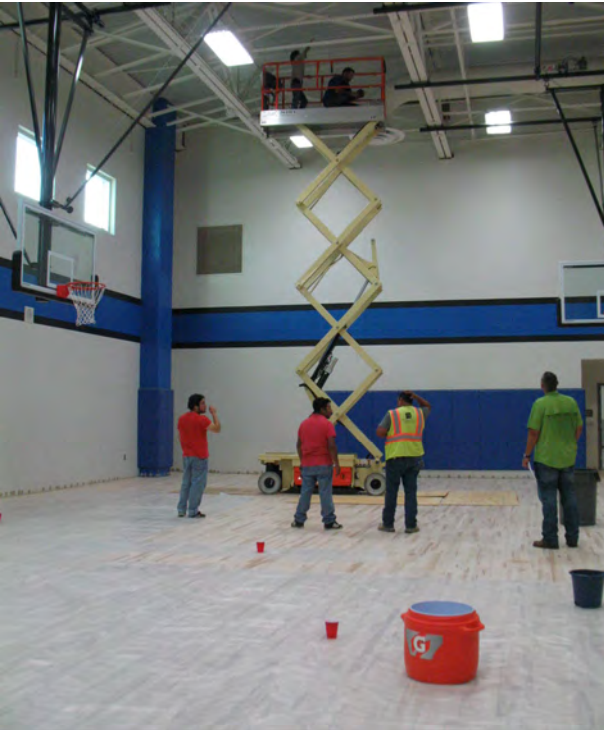
- ▶ During the summer, buckets were placed under leaks from roof deck.
- ▶ Testing of the modified bitumen roof system indicated that the roof system did not leak in any of the areas.

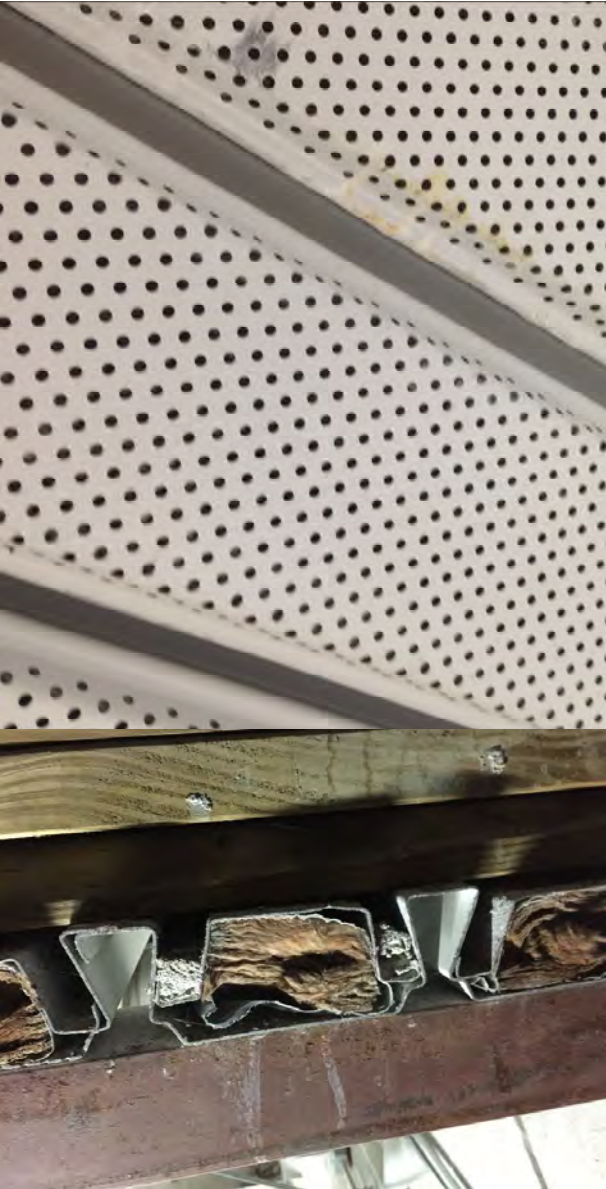
NEW SCHOOL ROOF CASE STUDY

- ▶ Acoustical deck with infill insulation
- ▶ Leaks were occurring randomly through the deck
